The Right to Clean Water in First Nations

The Photovoice Project 2nd Edition

The Photovoice Project

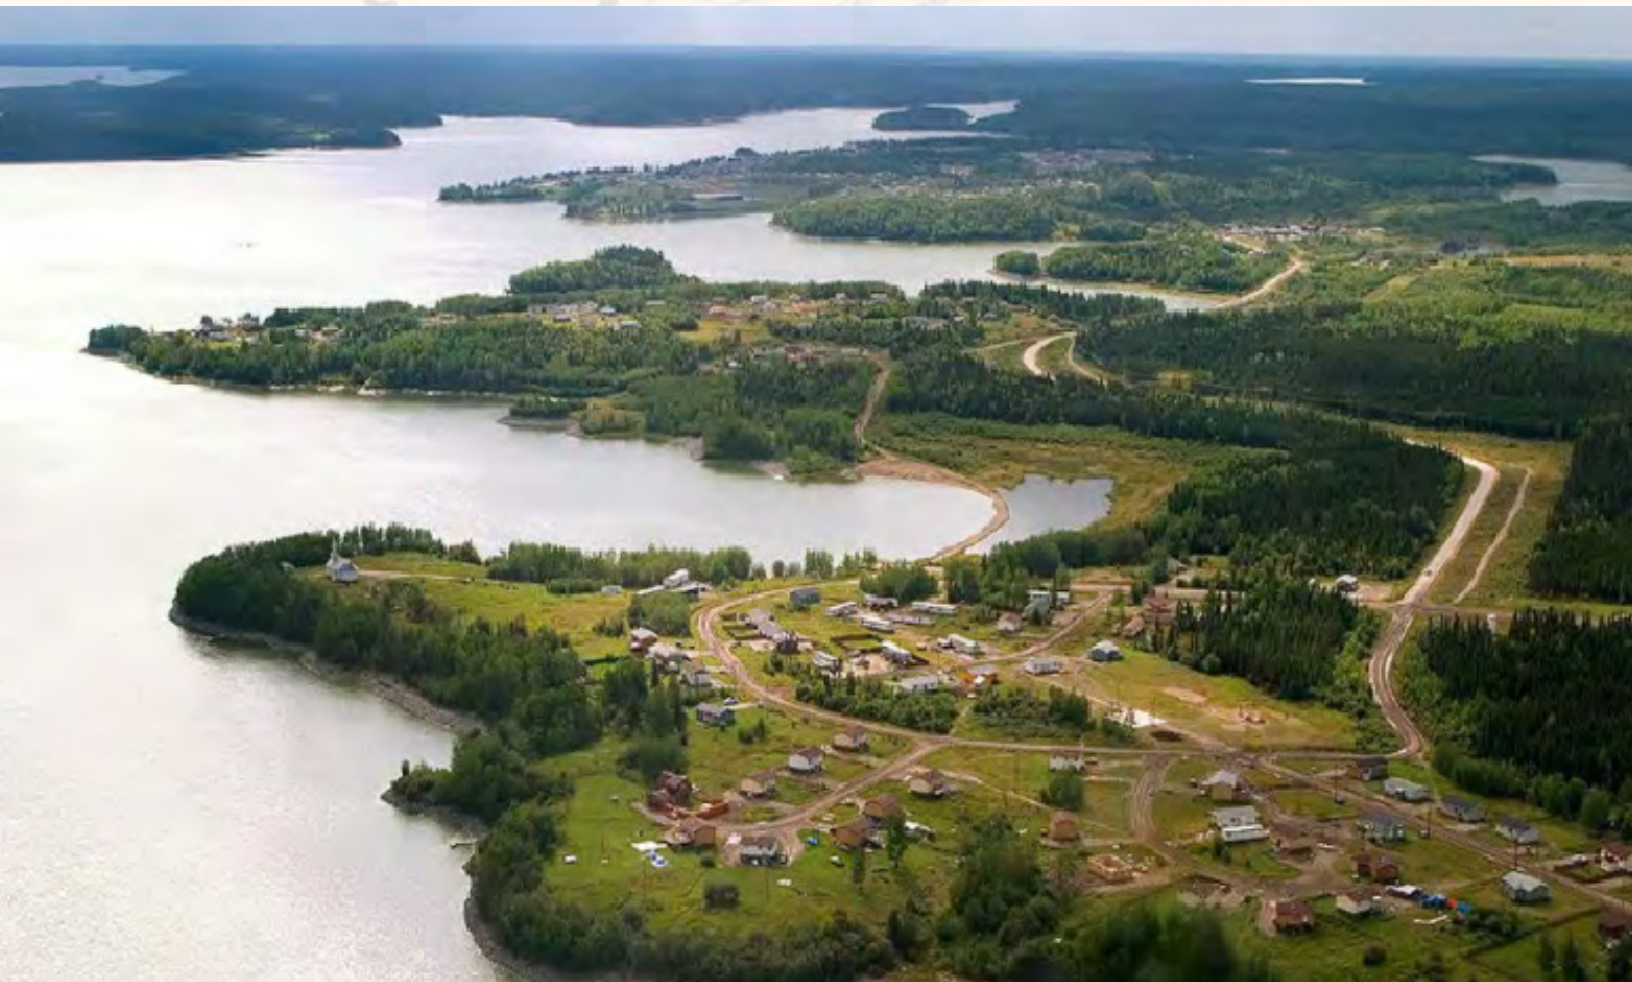
As in most northern reserves, Nisichawayasihk Cree Nation has fresh water surrounding it, but that doesn't mean it is easy to find a clean glass of it to drink.

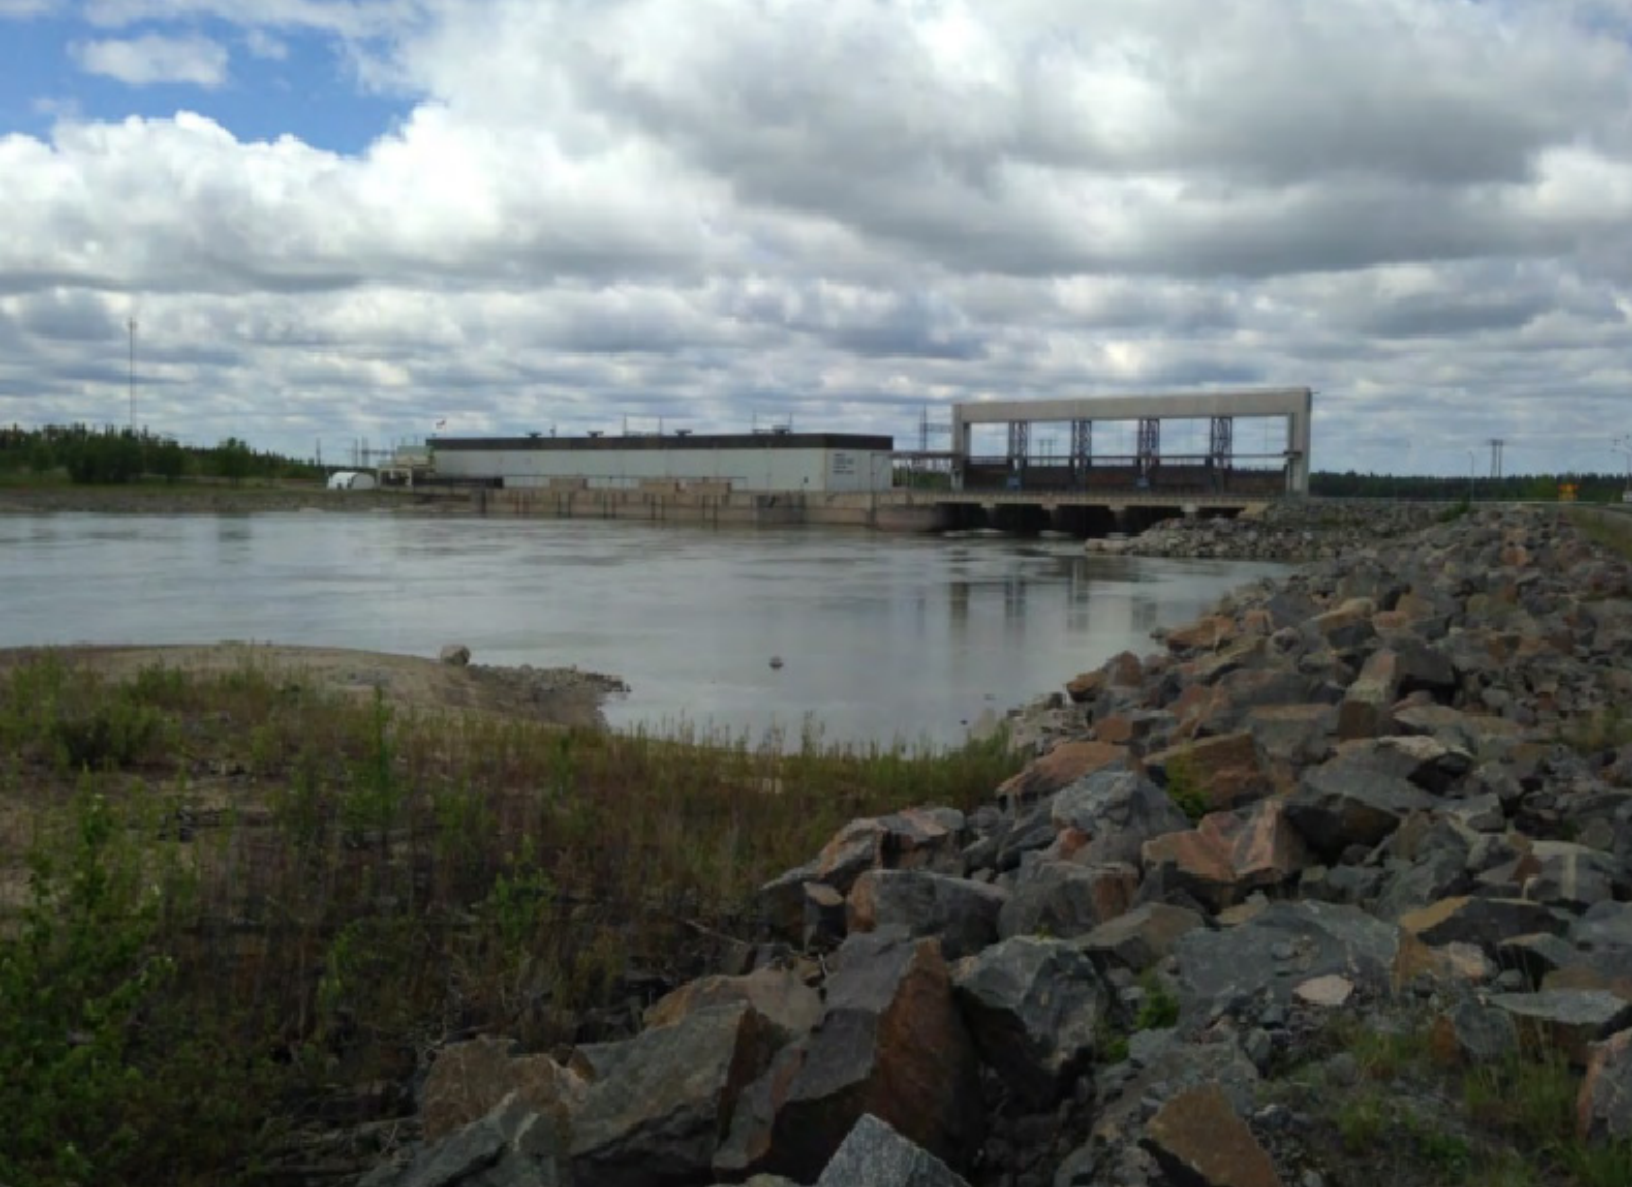
Hydro development across Northern Manitoba has had major effects on the water quality in the river and lakes. One result of dams, such as this one, is that our resource areas have been flooded.

We've experienced erosion and exposure to increases in mercury, which is washed into the water. In many situations, it has made the water unsafe to drink without treatment.

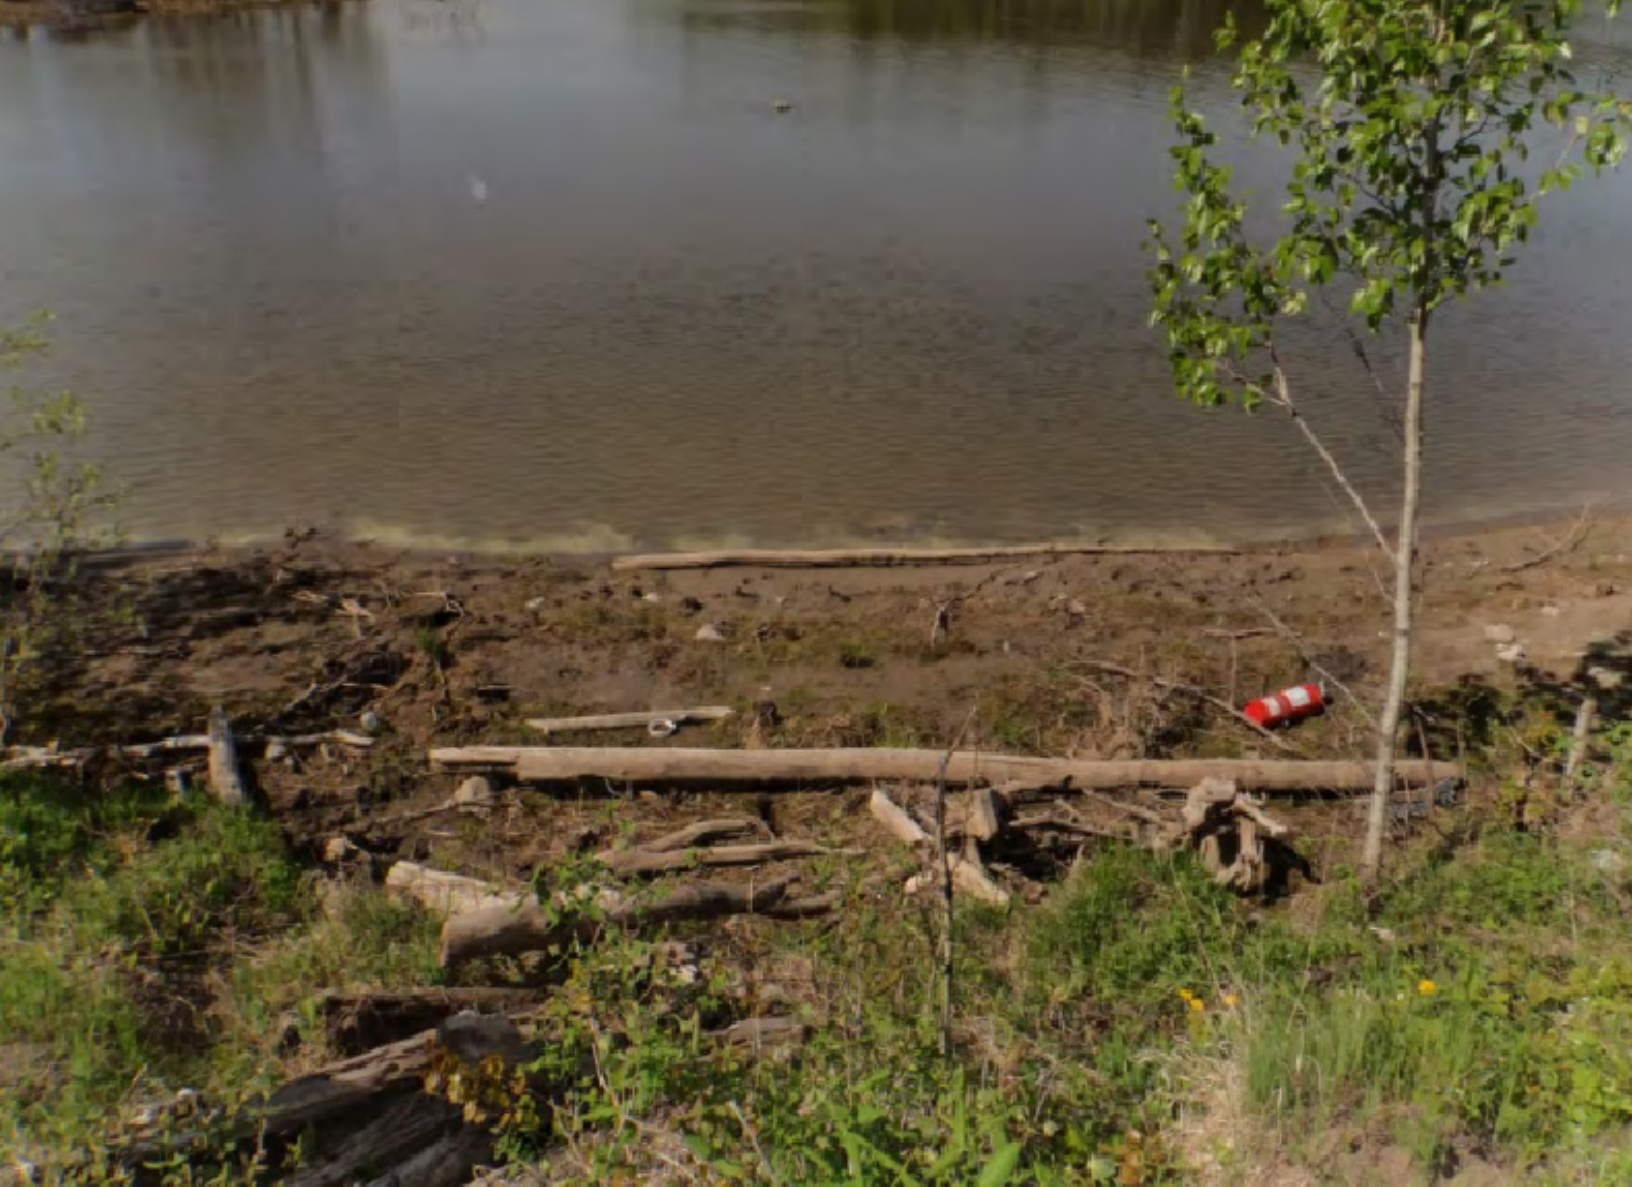
The shorelines of the lakes and rivers around Nisichawayasihk Cree Nation have been dramatically affected by fluctuating water levels due to hydro development. This has forced the community to spend a tremendous amount of money on water treatment.

You can see the levels of silt and decaying trees that have left the water dirty, contaminated and unsafe to drink ... but one day these defects will no longer be in play.

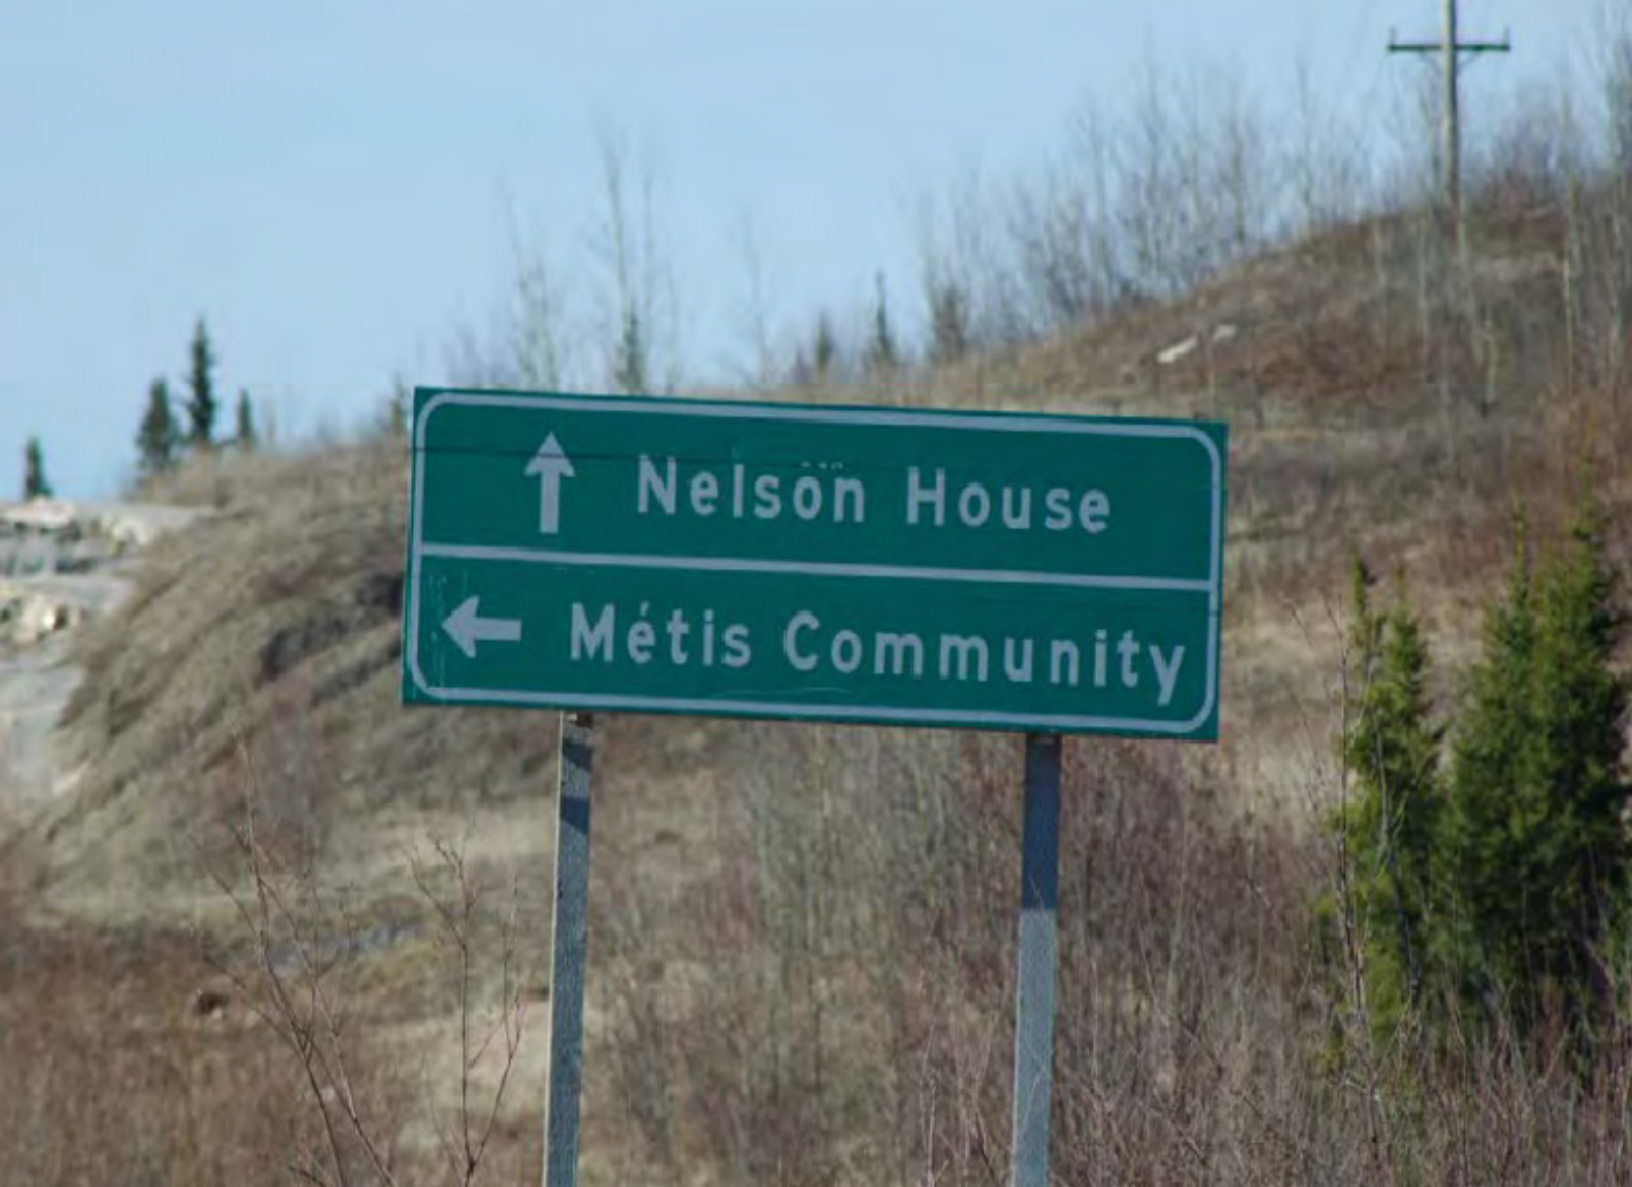
There are differences between federal and provincial legislation and responsibilities around safe drinking water. This can result in side by side communities having very different levels of water treatment, as is the case here.

The Métis community, being under provincial jurisdiction is seen by many to have a higher quality of water treatment.

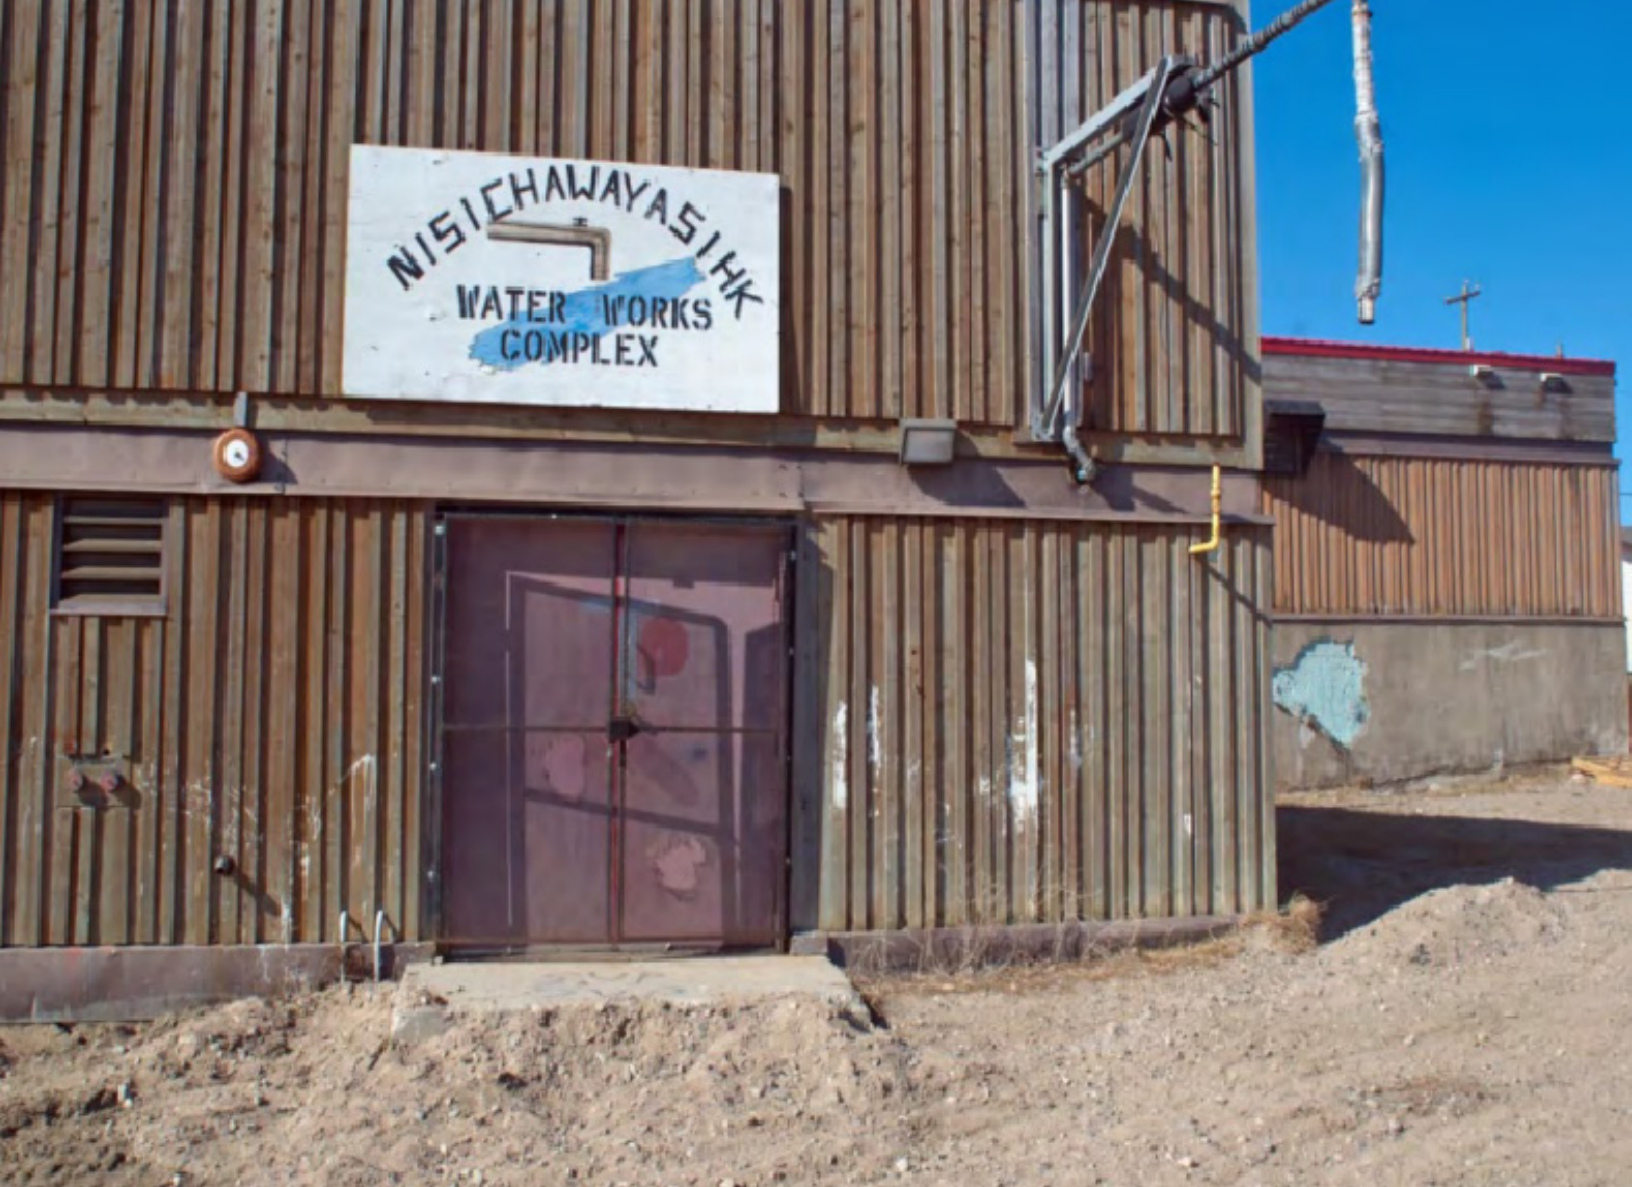
This is a picture of outside of the Water Treatment Complex. Though this complex has served the community well for a number of years, it is currently way too small for the demand being placed on it. This increases the risk of breakdowns and other water issues. In addition, its current size is holding back the needed construction of new houses and a school in the community.

1. Build a new treatment plant. The current one is old and working at over capacity.
2. Ensure qualified water treatment operators. There is a need for northern training, regulation and licensing. ATEC could play a role in this for northern communities.

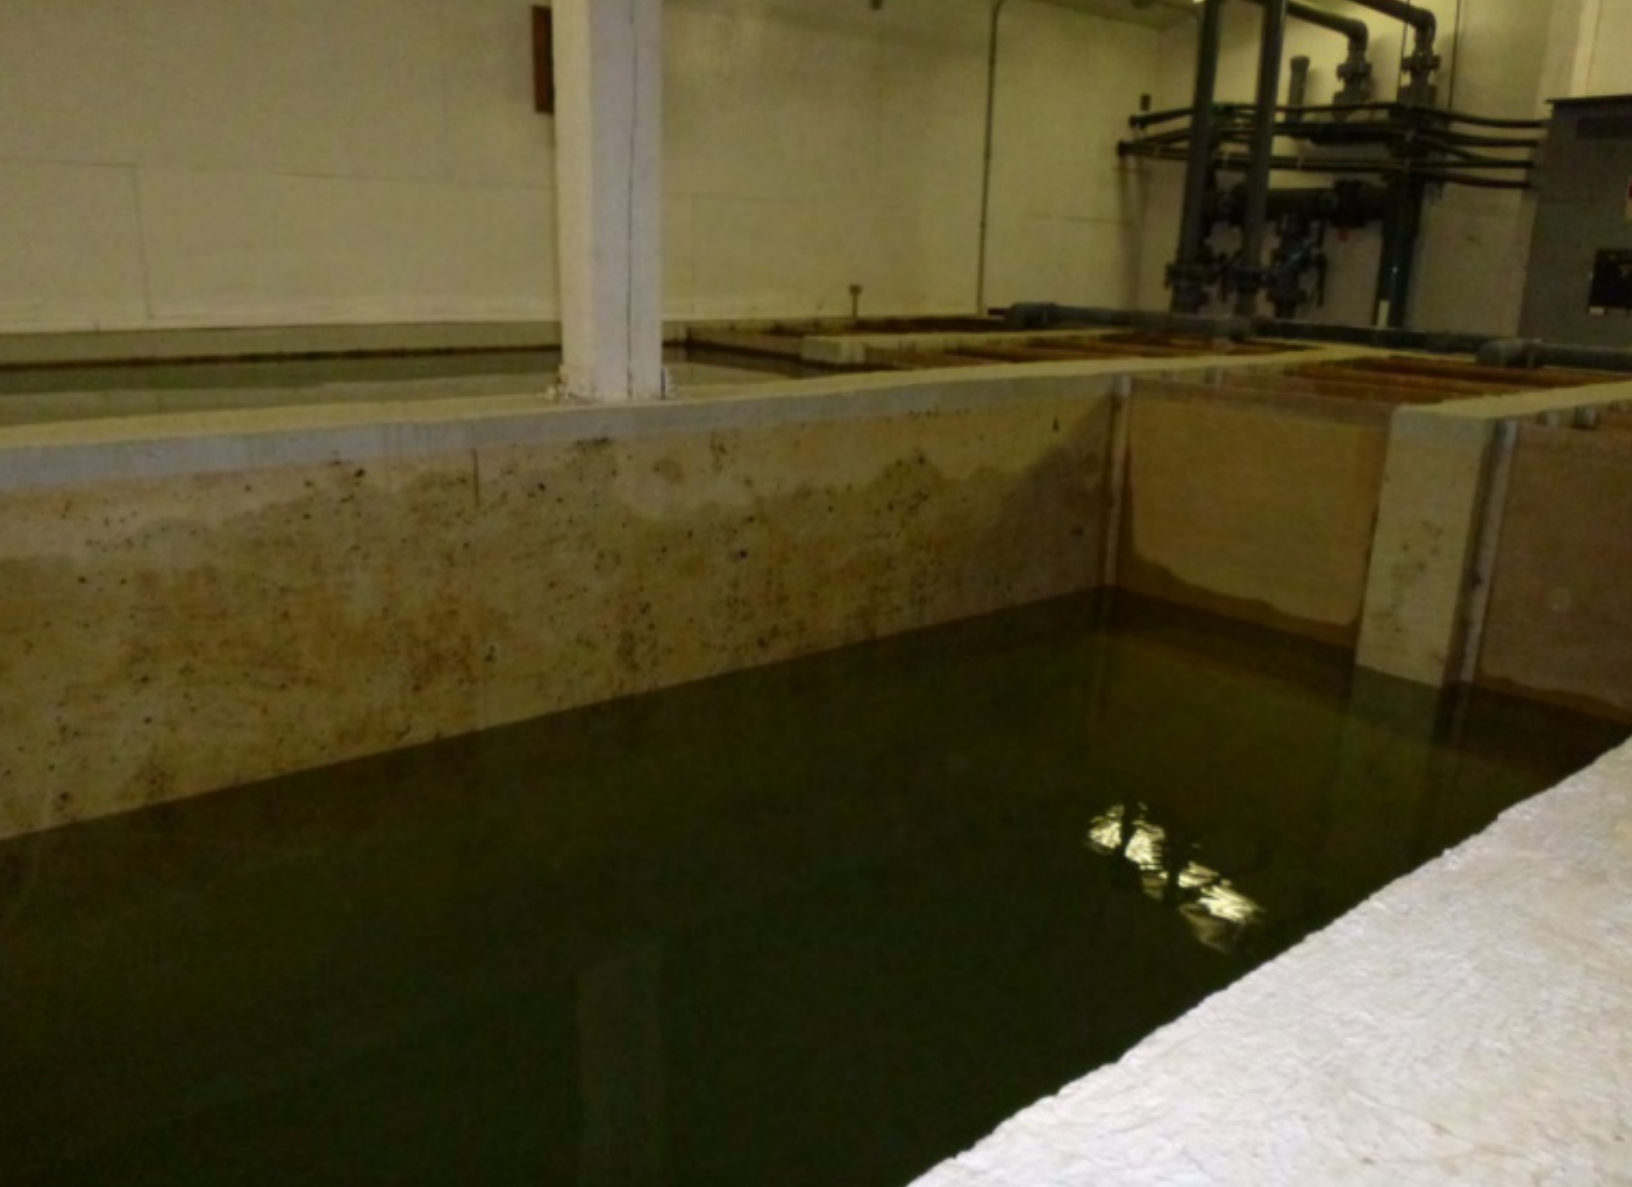
This is a picture of inside the Nelson House water treatment plant. We use these tanks to generate water to every house that has running water. There is high silt content in our water but we know how to treat the water and make it potable.

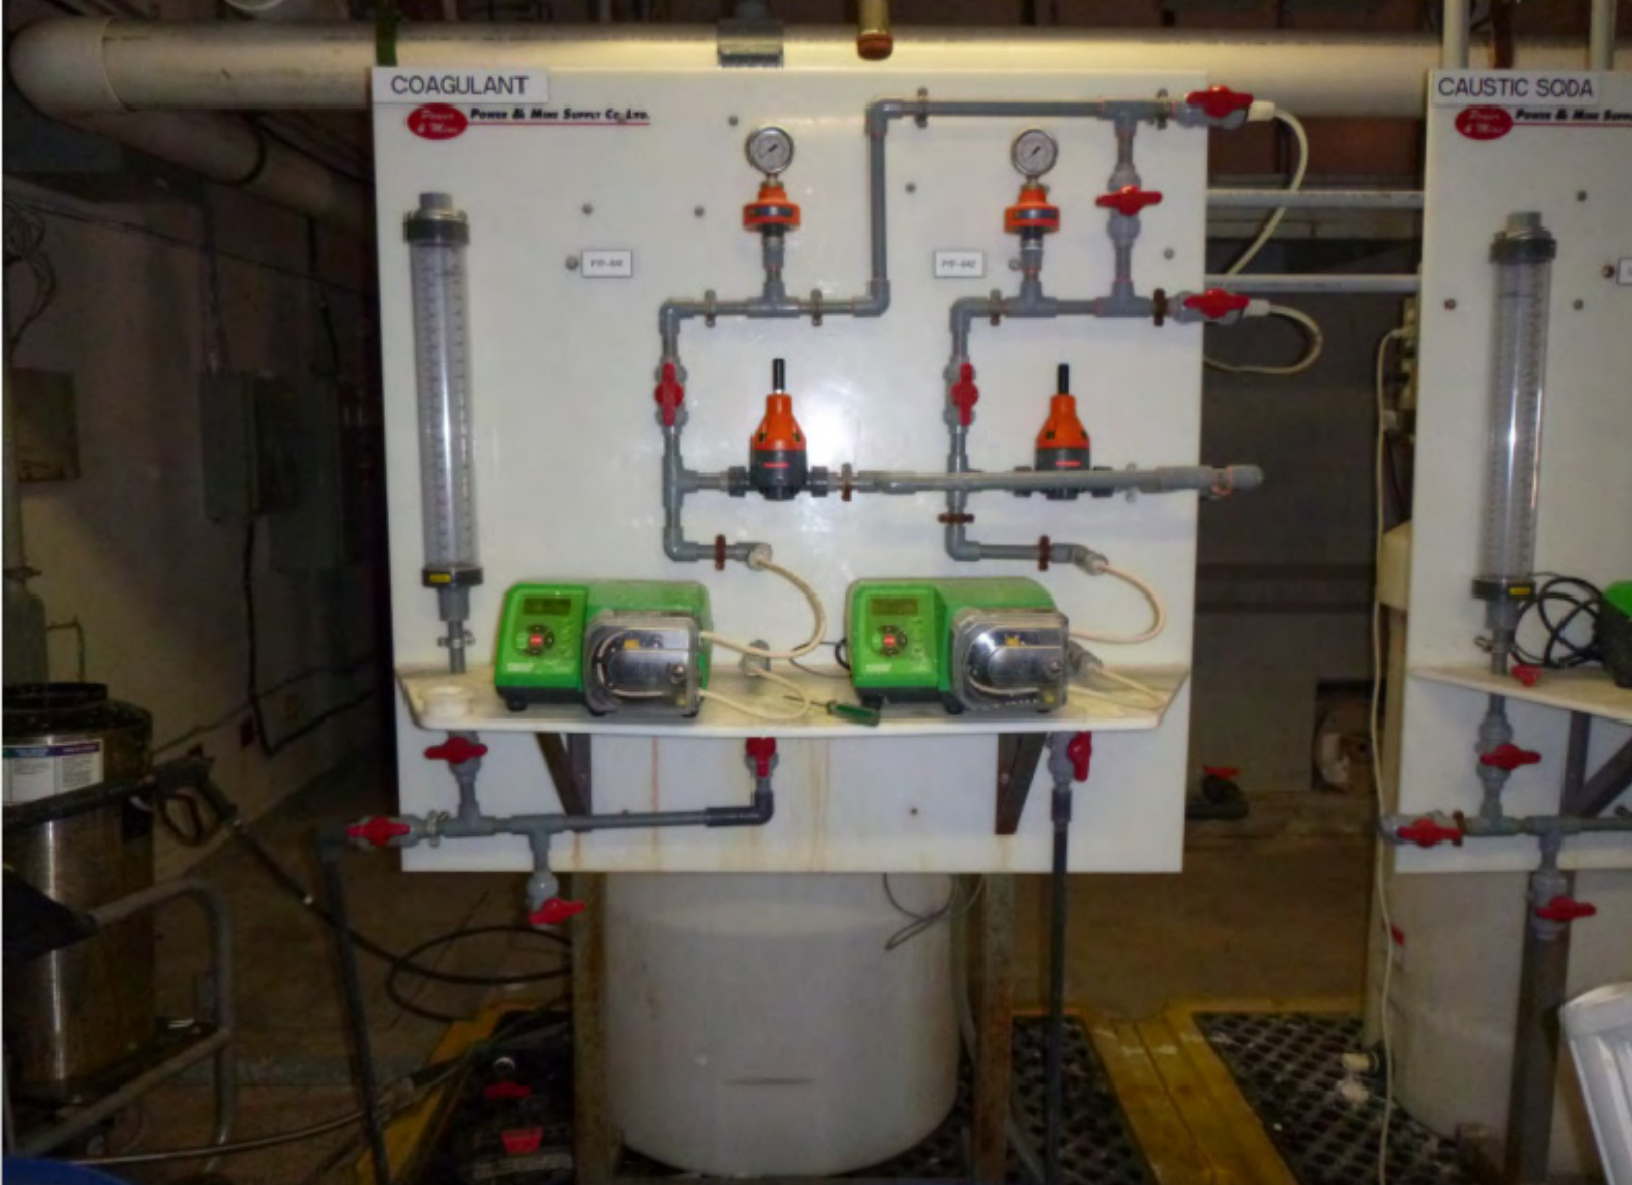
In the water treatment plant we use chemicals to treat the water so it could be drinkable. The equipment, though old, does a good job of cleaning the water and making it safe to drink. The problem is that the system, being too small for the current population and demand, has to work way over capacity. This can lead to breaks and shut downs.

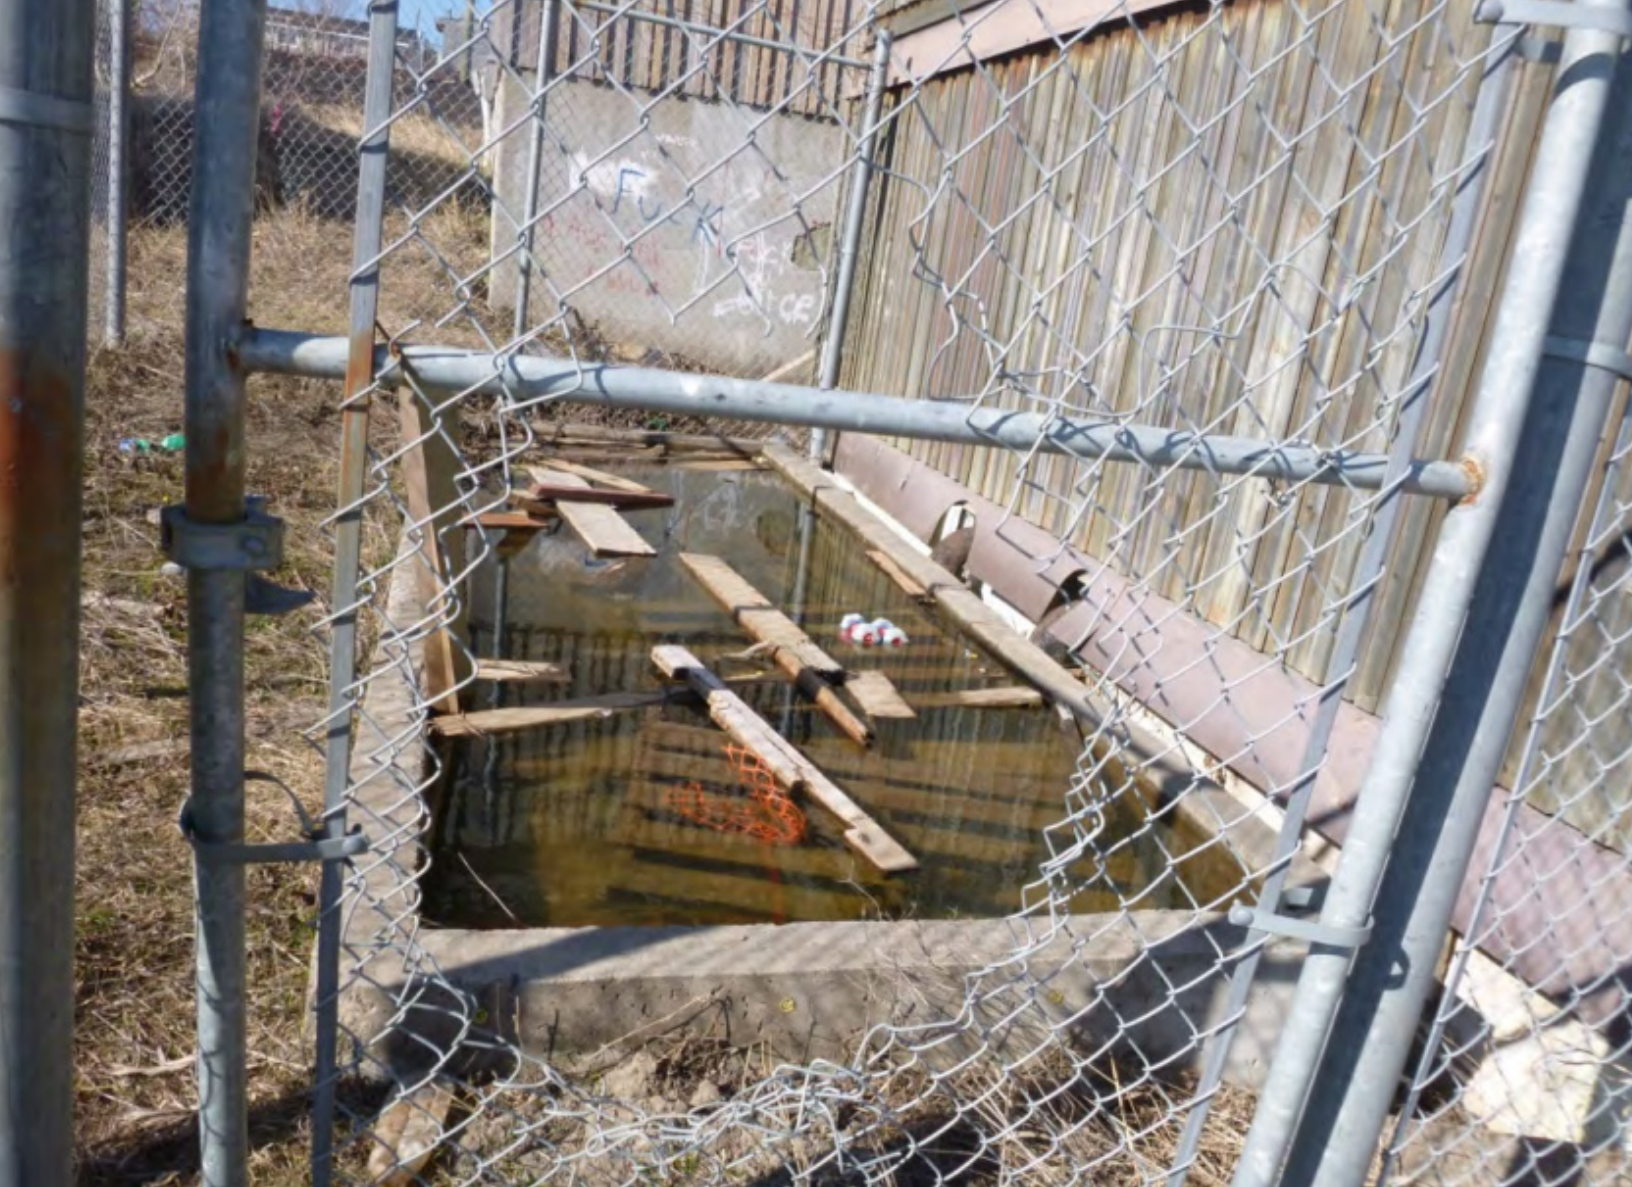
The water treatment plant needs many repairs and upgrades. It may be better to build a whole new plant than spend money repairing this one.

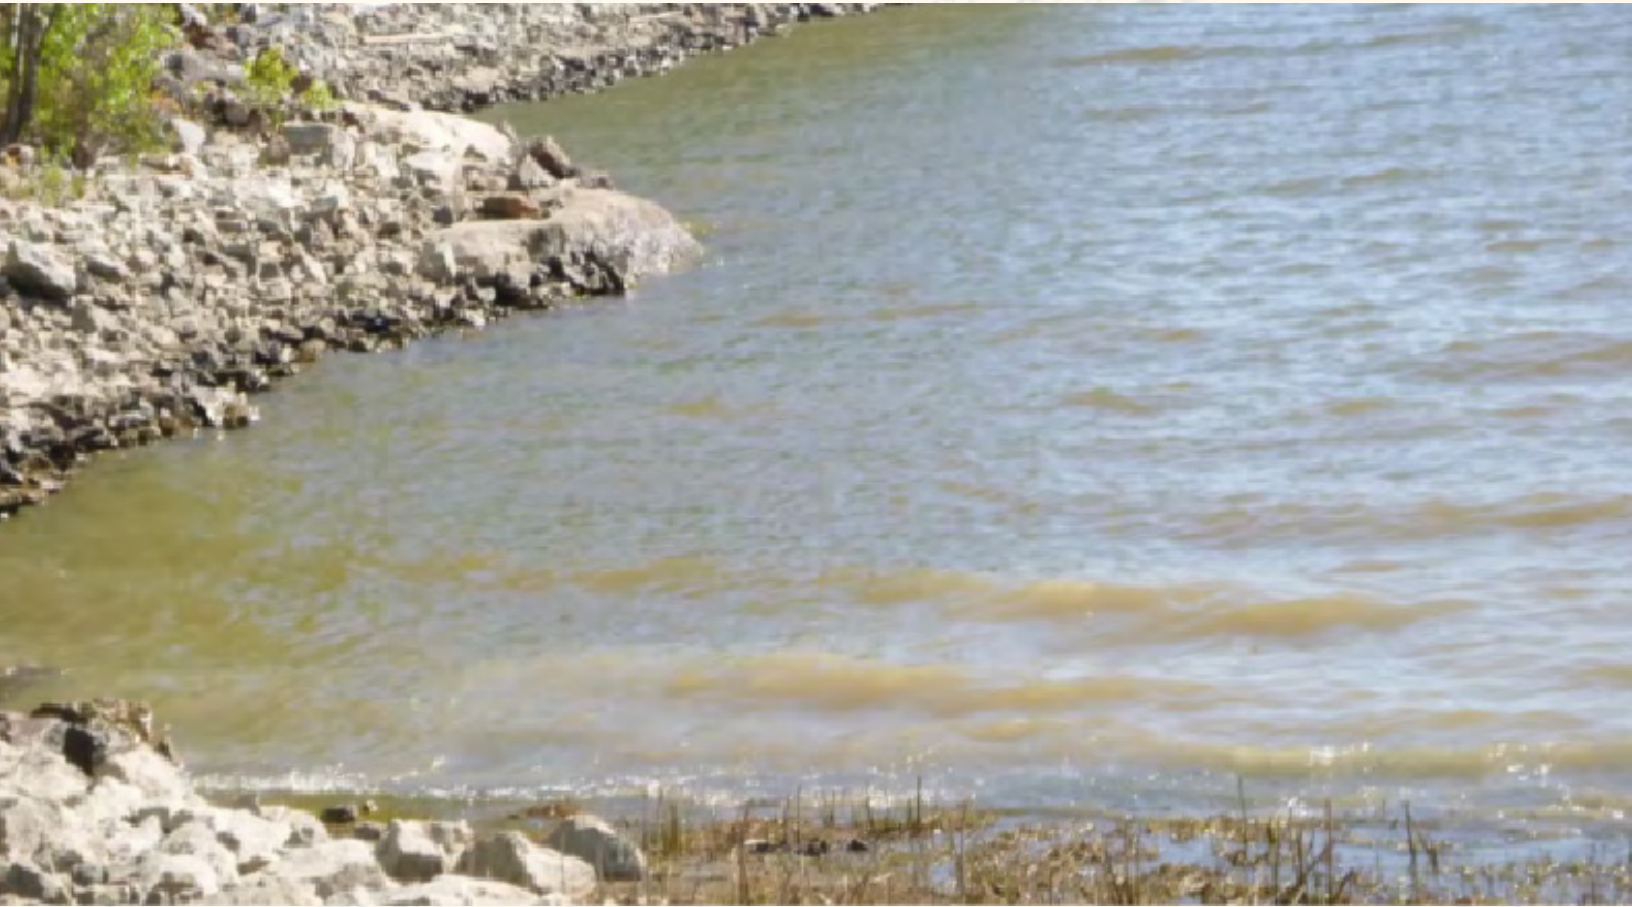
The bay is by Gilbert McDonald Arena here in Nelson House. Just above the bay there is a water filling station located on the left side. From this view there is a culvert that drains into this bay. The drainage is from the ditches along the side of the roads that drains rain and snow. Going on for several years there has been a few too many water breaks that flowed into this drainage.

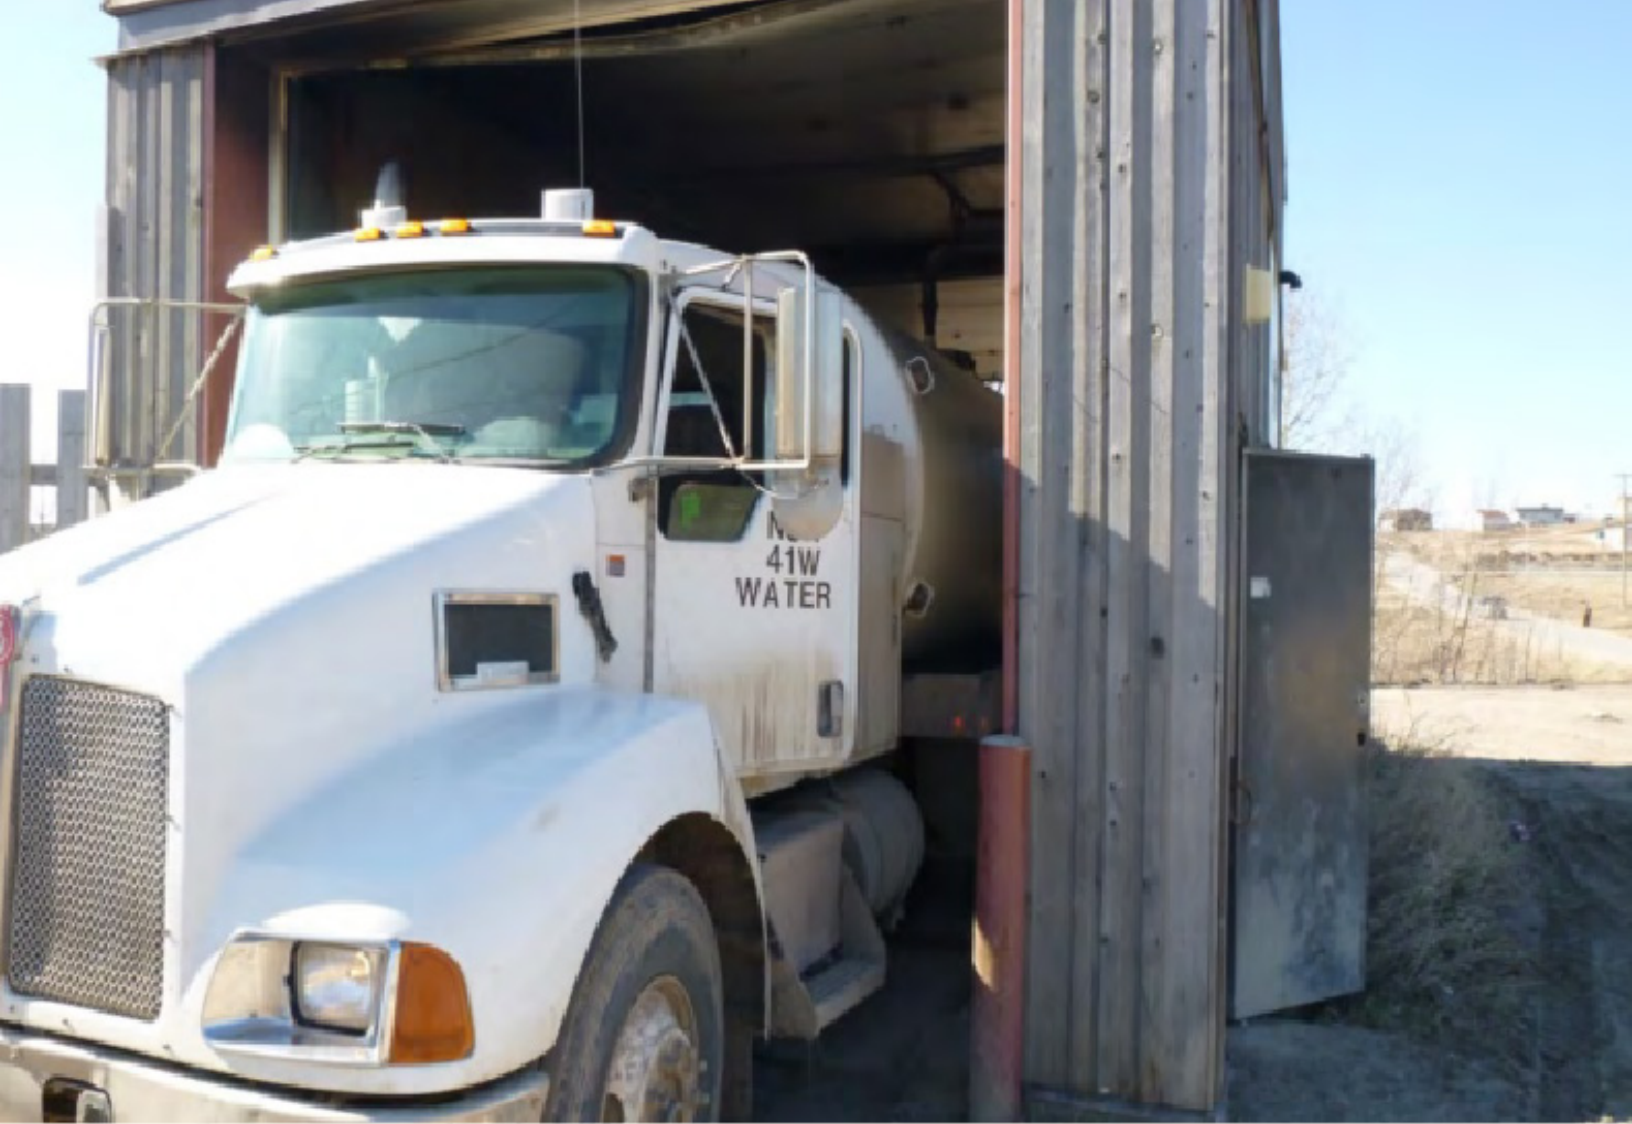
Water trucks provide water to the local houses that don't have water lines connected to their homes. There are three different areas Micelle Point, Dog Point and R.C. Point where the houses have water and sewage tanks. During the winter season some or many of the pipes tend to freeze up when the weather is 30-40 below. And that is when our neighbours tend to come get water and use the shower/bath, laundry, cooking etc... The trucks run on a schedule during the week and on weekends for emergency purposes. It is great that we have water trucks. Why you might ask. With only having one fire truck we could have water when the fire hydrants are not operational.

3. Extend piped water to entire reserve.
4. Reduce the risk of contaminations due to excess handling and storage of drinking water. This includes more cleaning/flushing of tanks on a regular schedule.

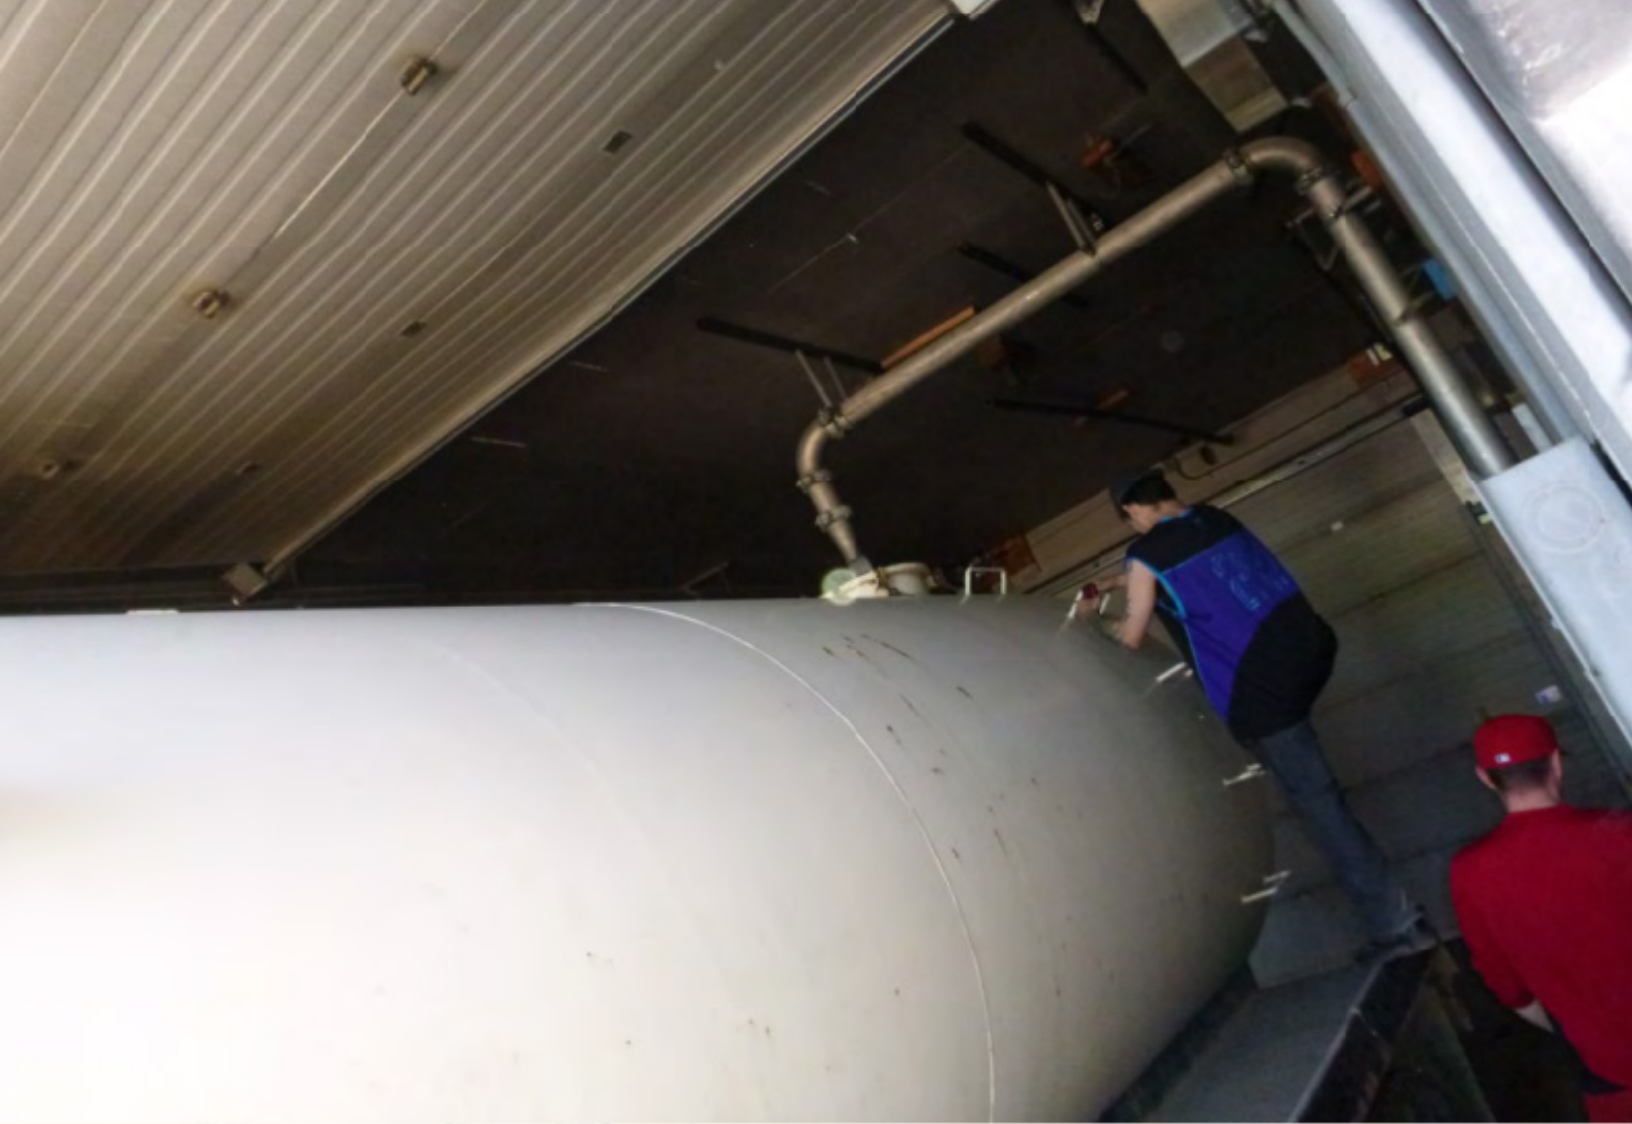
This is a glimpse of what the water filling station looks like on the inside. The workers fill the water trucks here and deliver it to about 50% of the community members that are dependent on water tanks and sewage tank systems. The other 50% have piped water to their homes.
