The Right to Clean Water in First Nations

The Photovoice Project 2nd Edition

The Photovoice Project

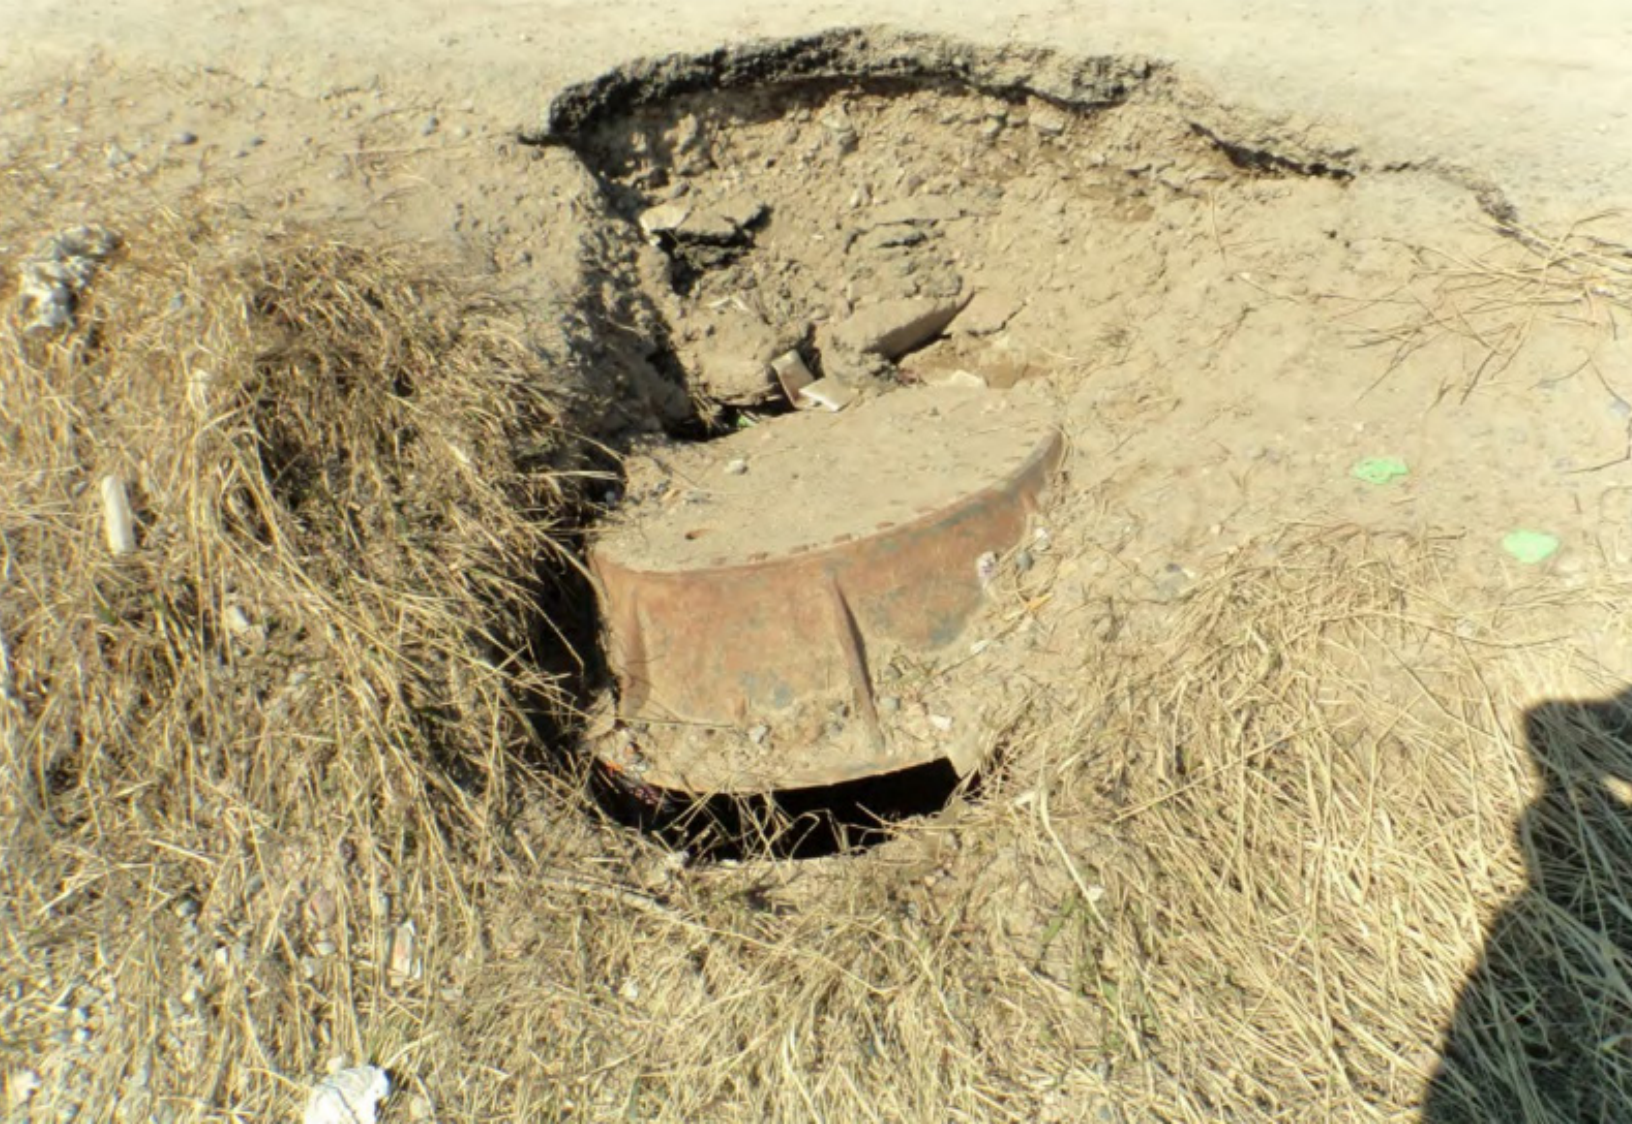
Soil erosion in the community has caused much damage to the current water system. This adds to further risk of damage, personal injury and breakdown. Much needs to be done to get our system up to proper standards.

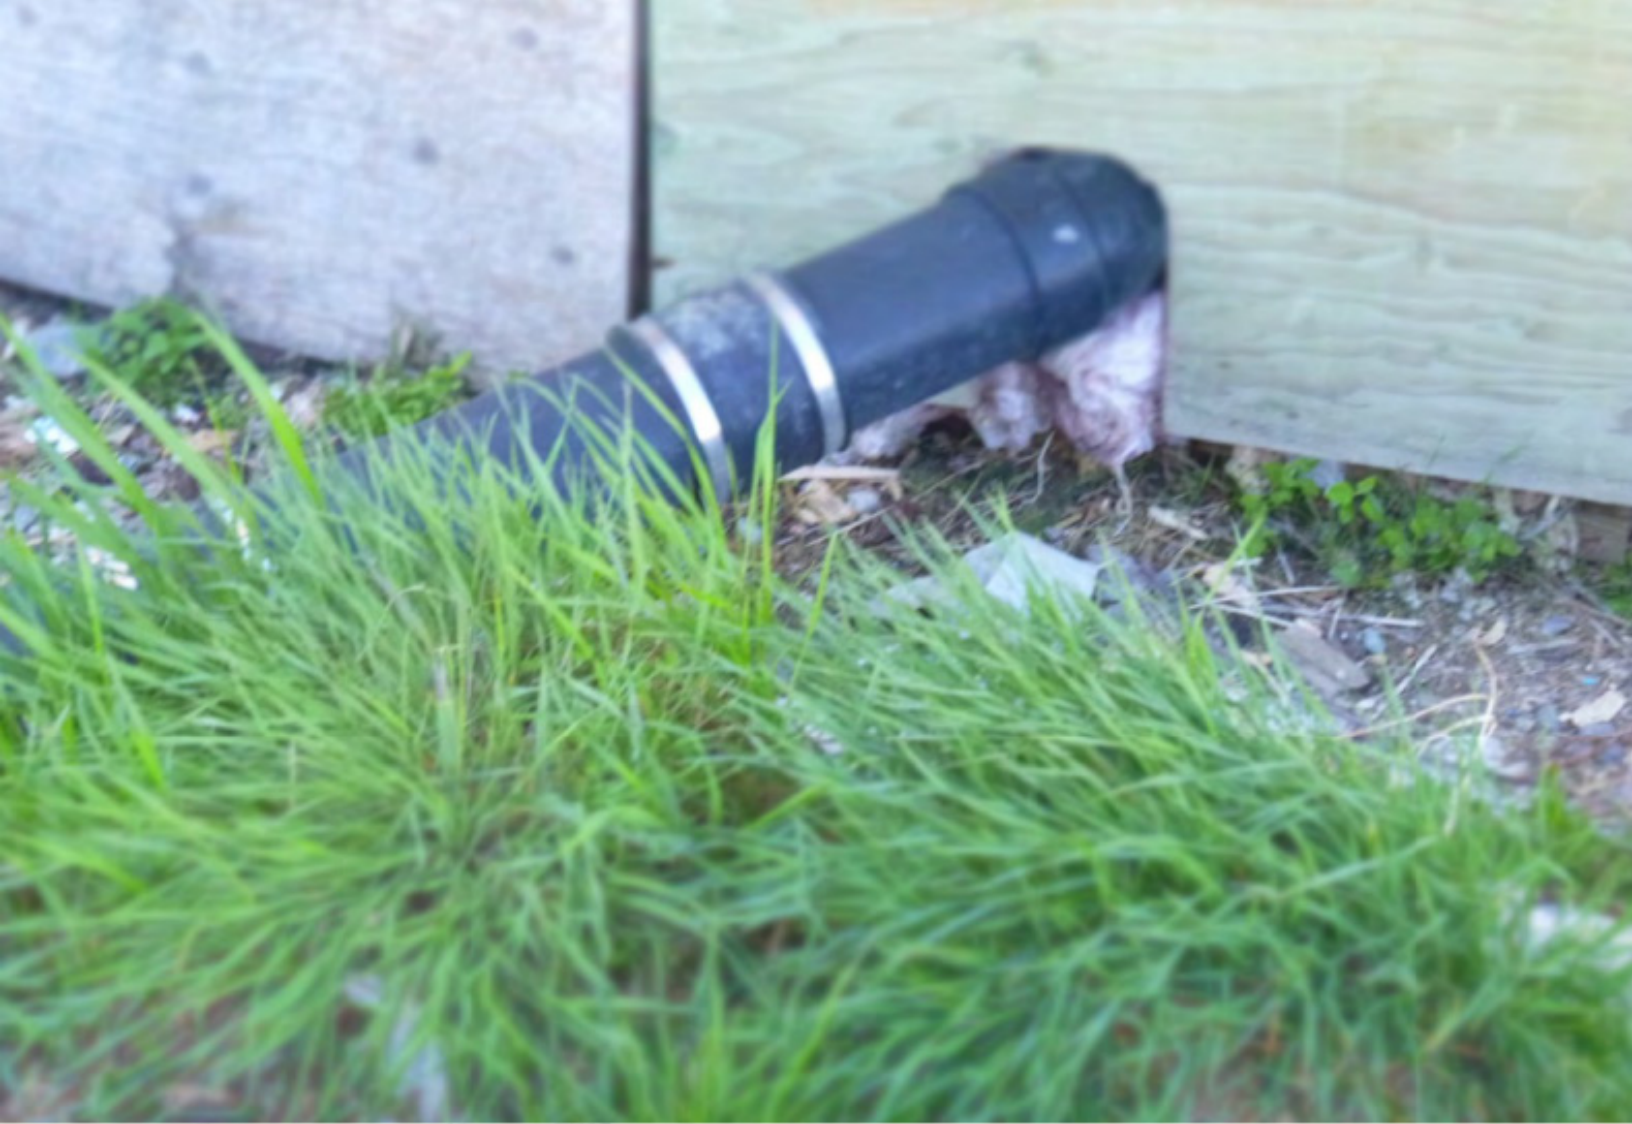
The picture is from a home we have in the community. Before this home was put here the previous home burnt down. The exposed pipe shown is a water pipe that is supposed to be underground to prevent the pipe from freezing during the winter season. The new residents of this home will now experience frozen pipes every winter season.

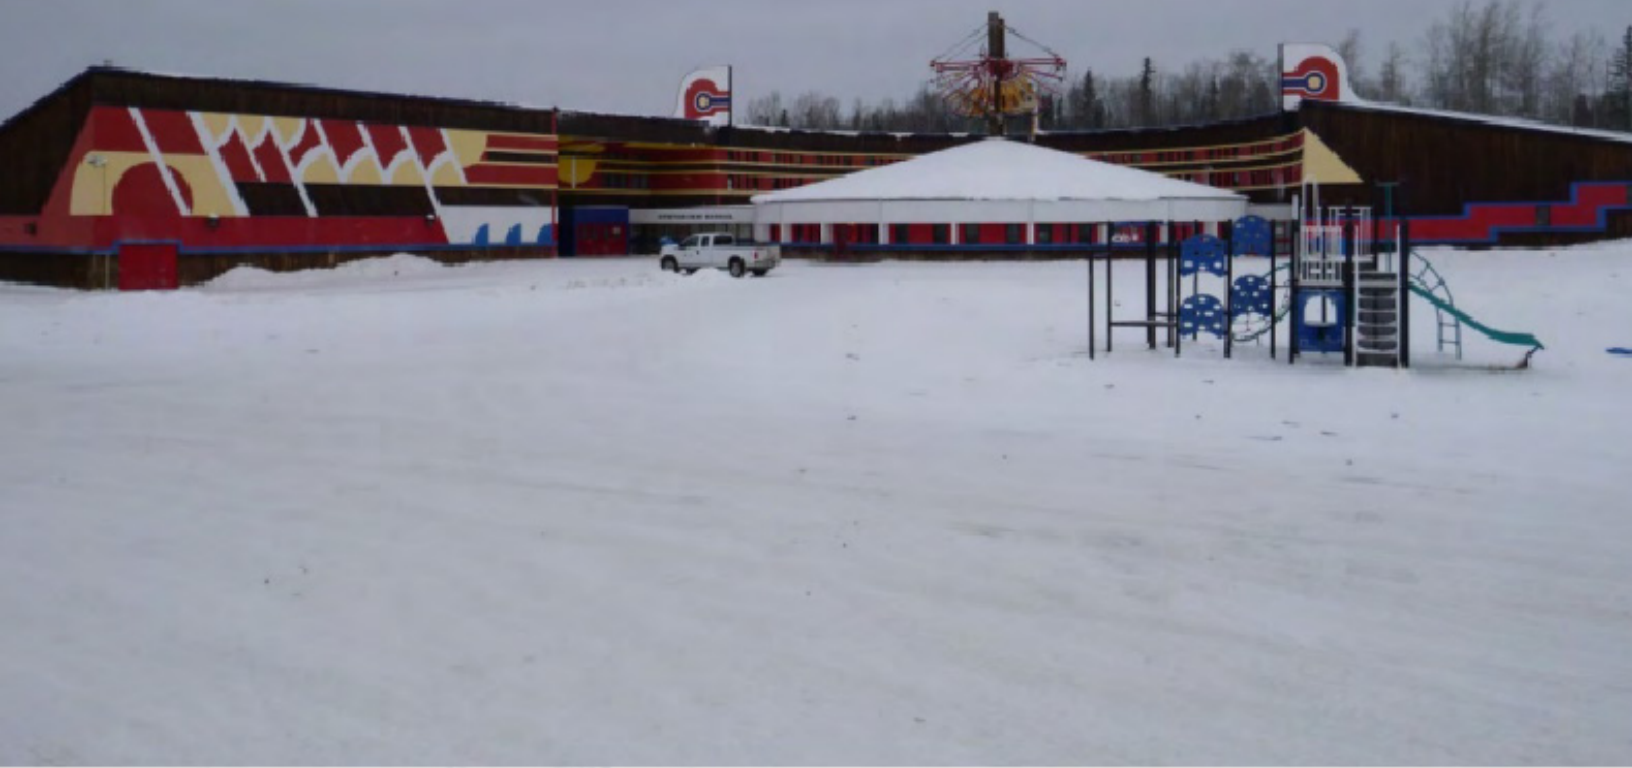
The Otetiskiwin Kiskinwamahtowekamil (O.K.) School and Nisichawayasihk Noyo Collegiate (N.N.O.C.) School were closed the week of September 8th-12, 2014. Around 900 students and teachers were affected due to plumbing problems underneath the building and could not attend class for a week. The plumber from Winnipeg said it was only a temporary fix because we don't have the right pipes. Will this keep happening to the students? Expectations are that it will, on a larger scale.

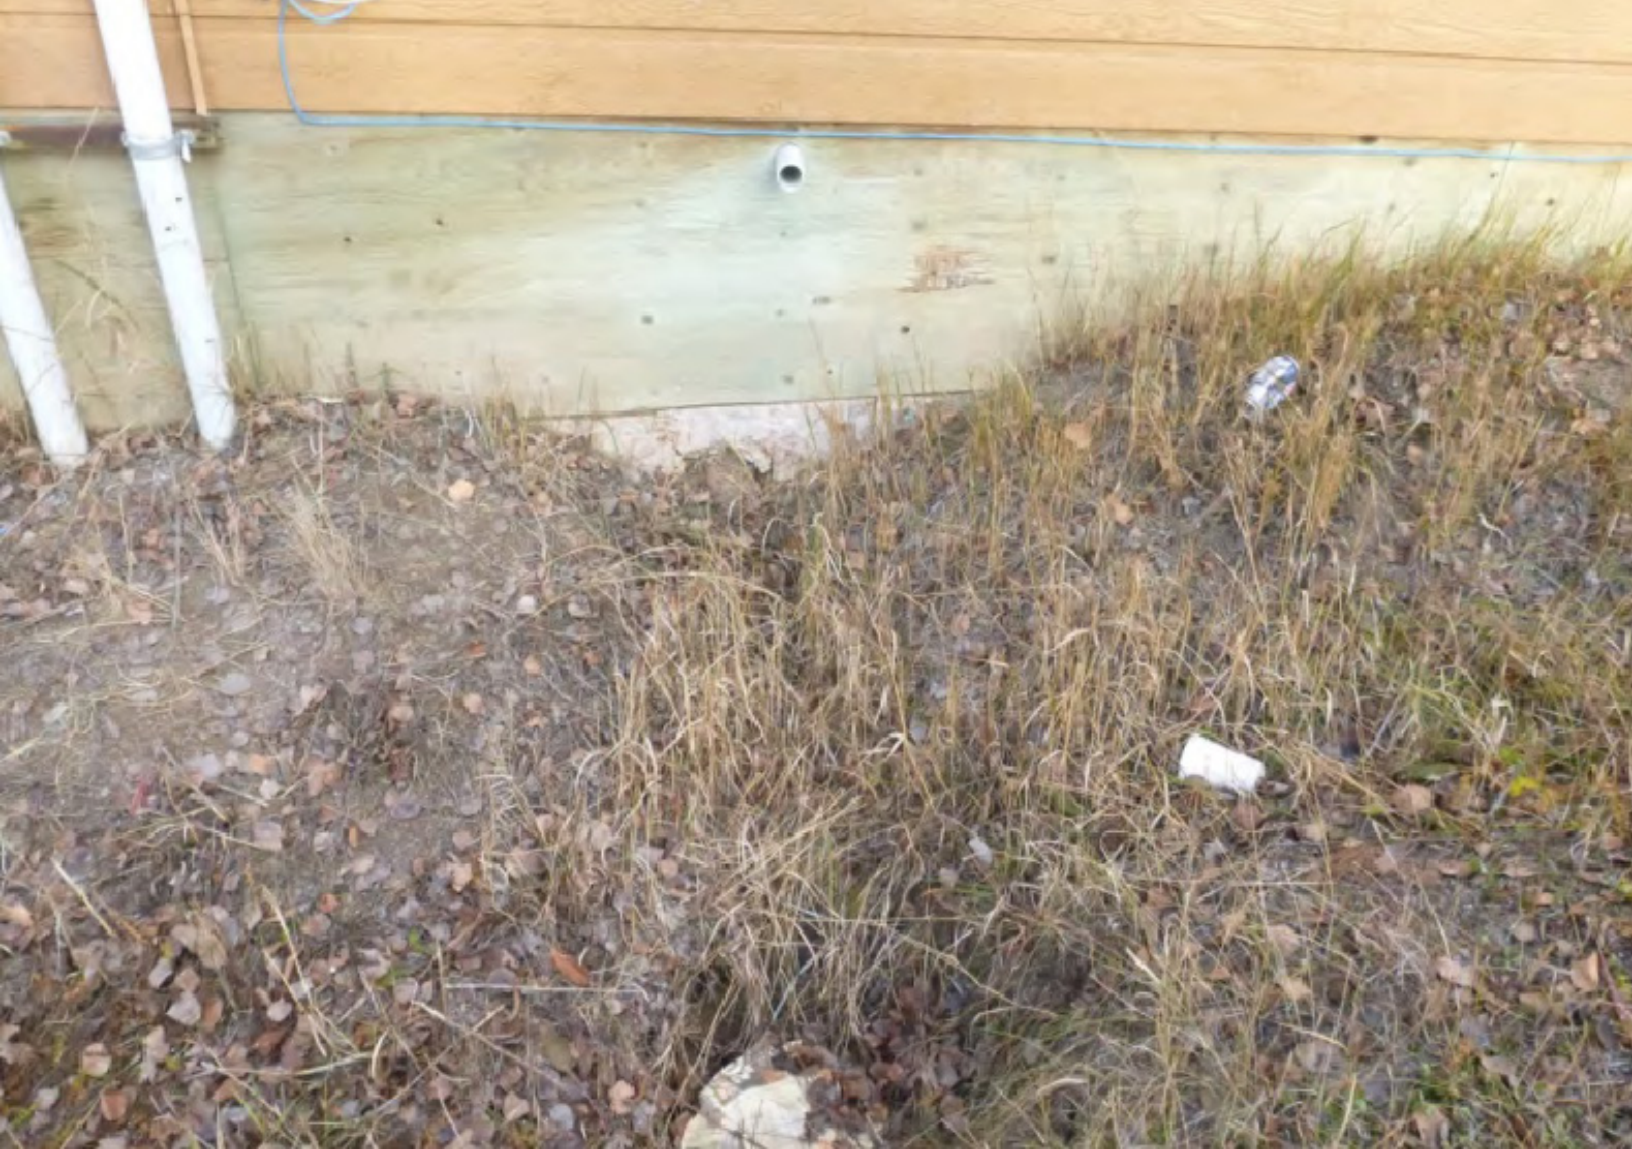
This is a photo of a building across from the Atoskiwin Training & Employment Centre of Excellence (ATEC) in Nelson House. You can see a pipe sticking out of the building leading to nowhere. For some reason there is always water running out of it in the summer. Can you see the hole in the ground where the water has landed and runs down forming a ditch? This flow has also damaged the foundation of the building and there is a power box nearby that increases the risk of injury. The O.K. School is also just down the road.

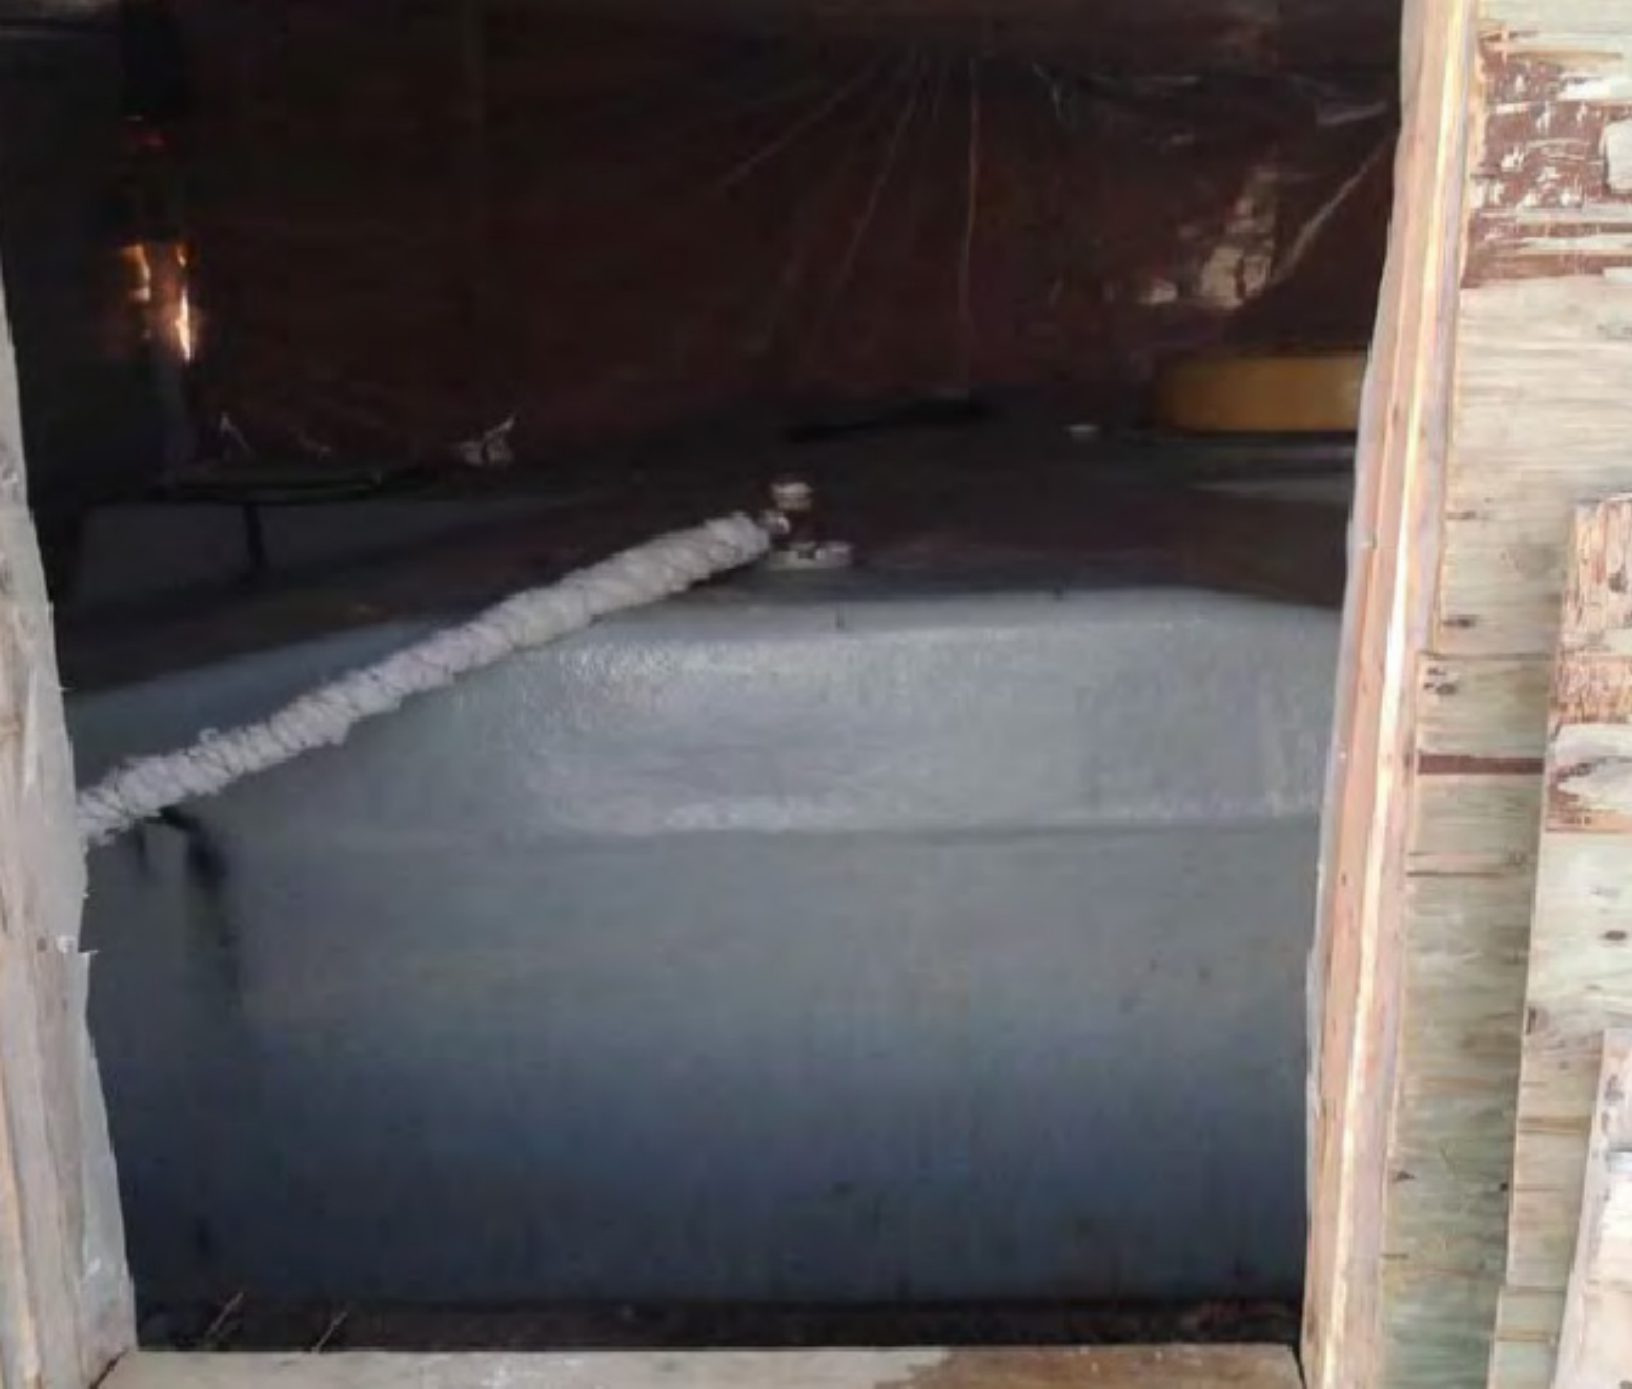
This is a picture of the entrance to a water tank shack. As you can see, there are some openings in the left corner where rain water and snow can get in. These holding tanks can become a huge problem. The inside of the tank needs to be cleaned on a regular basis, which is expensive and the Band often does not have enough money to do this. The tanks freeze over the winter and cause clogged and cracked pipes. When summer arrives the frozen tanks melt and flood the basements that cause mold. This is an unhealthy environment to live in.

3. Extend piped water to entire reserve.
4. Reduce the risk of contaminations due to excess handling and storage of drinking water. This includes more cleaning/flushing of tanks on a regular schedule.

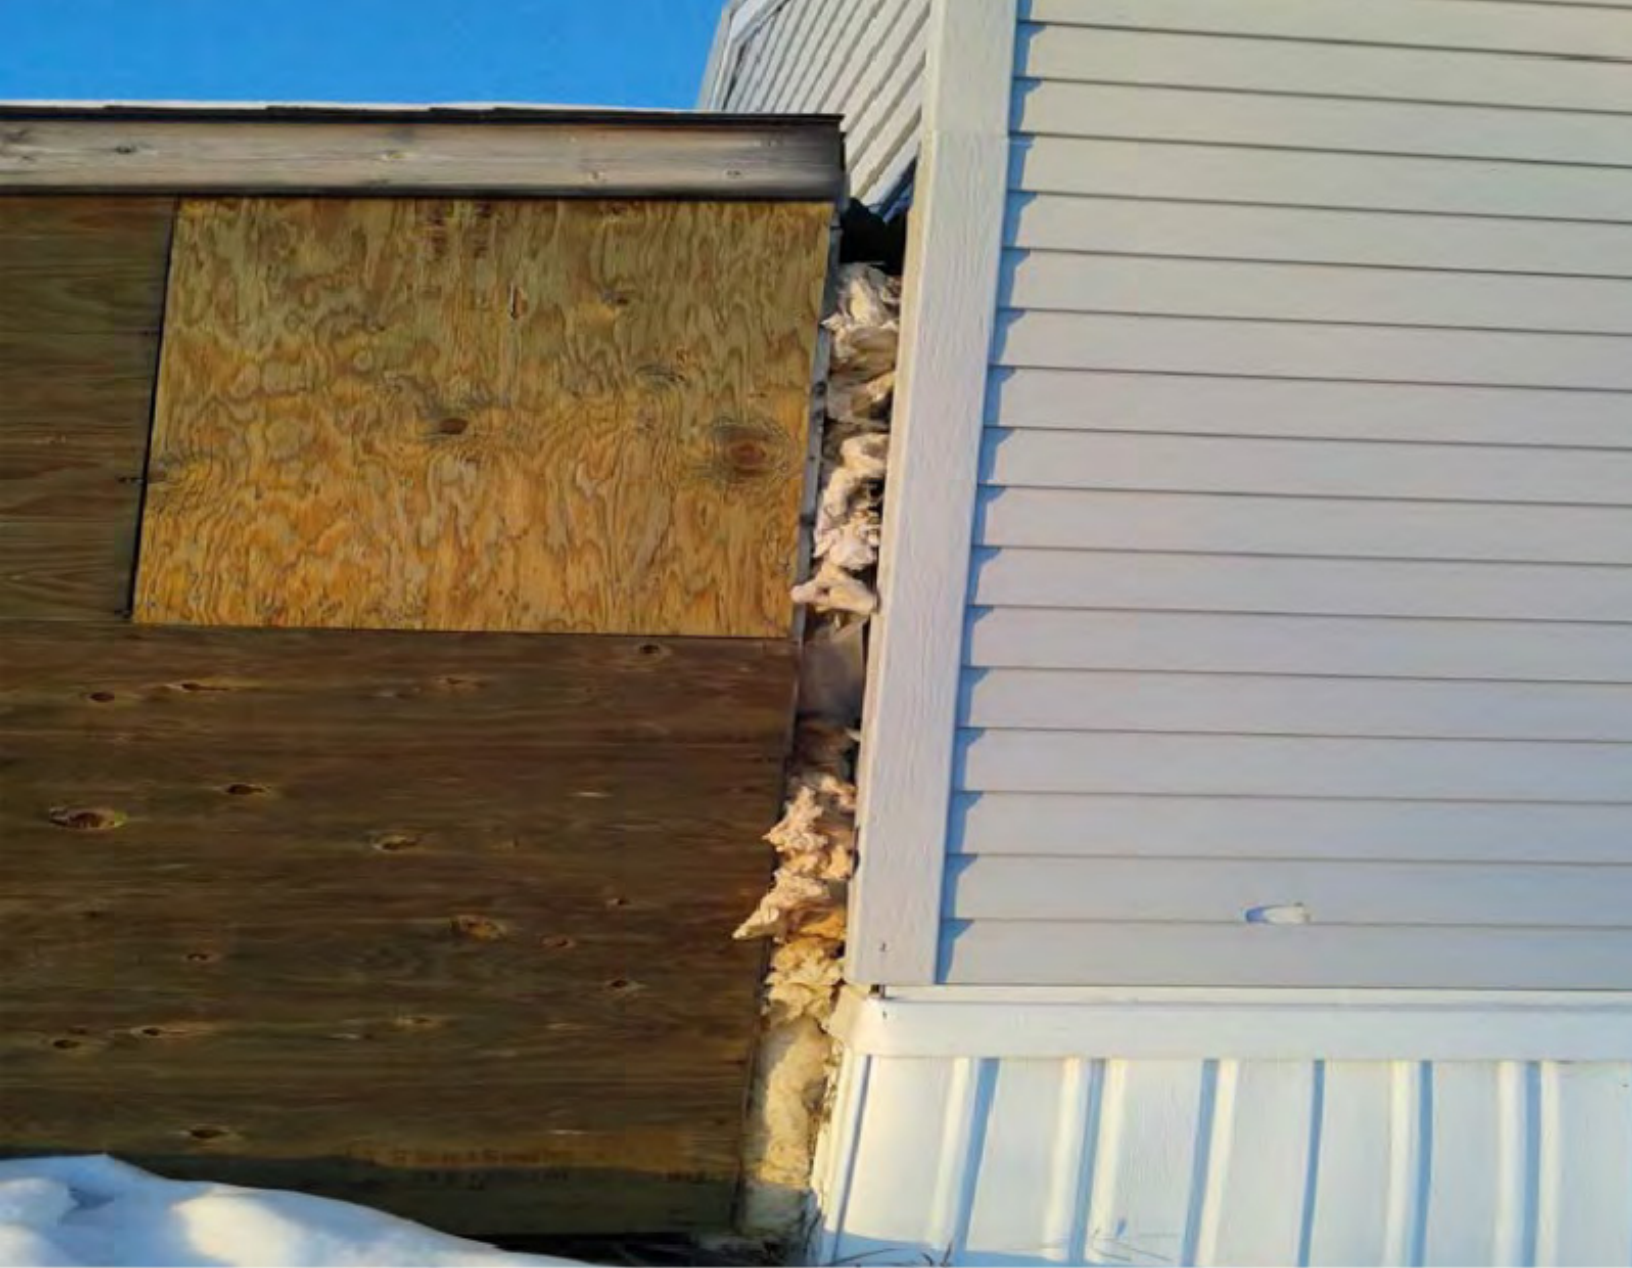
In the last photo you saw the inside, now here is the outside view of the water tank shack where it was built to connect to the house. It shifted over the past couple of years and we had to put insulation in the cracks to try and keep the cold out.

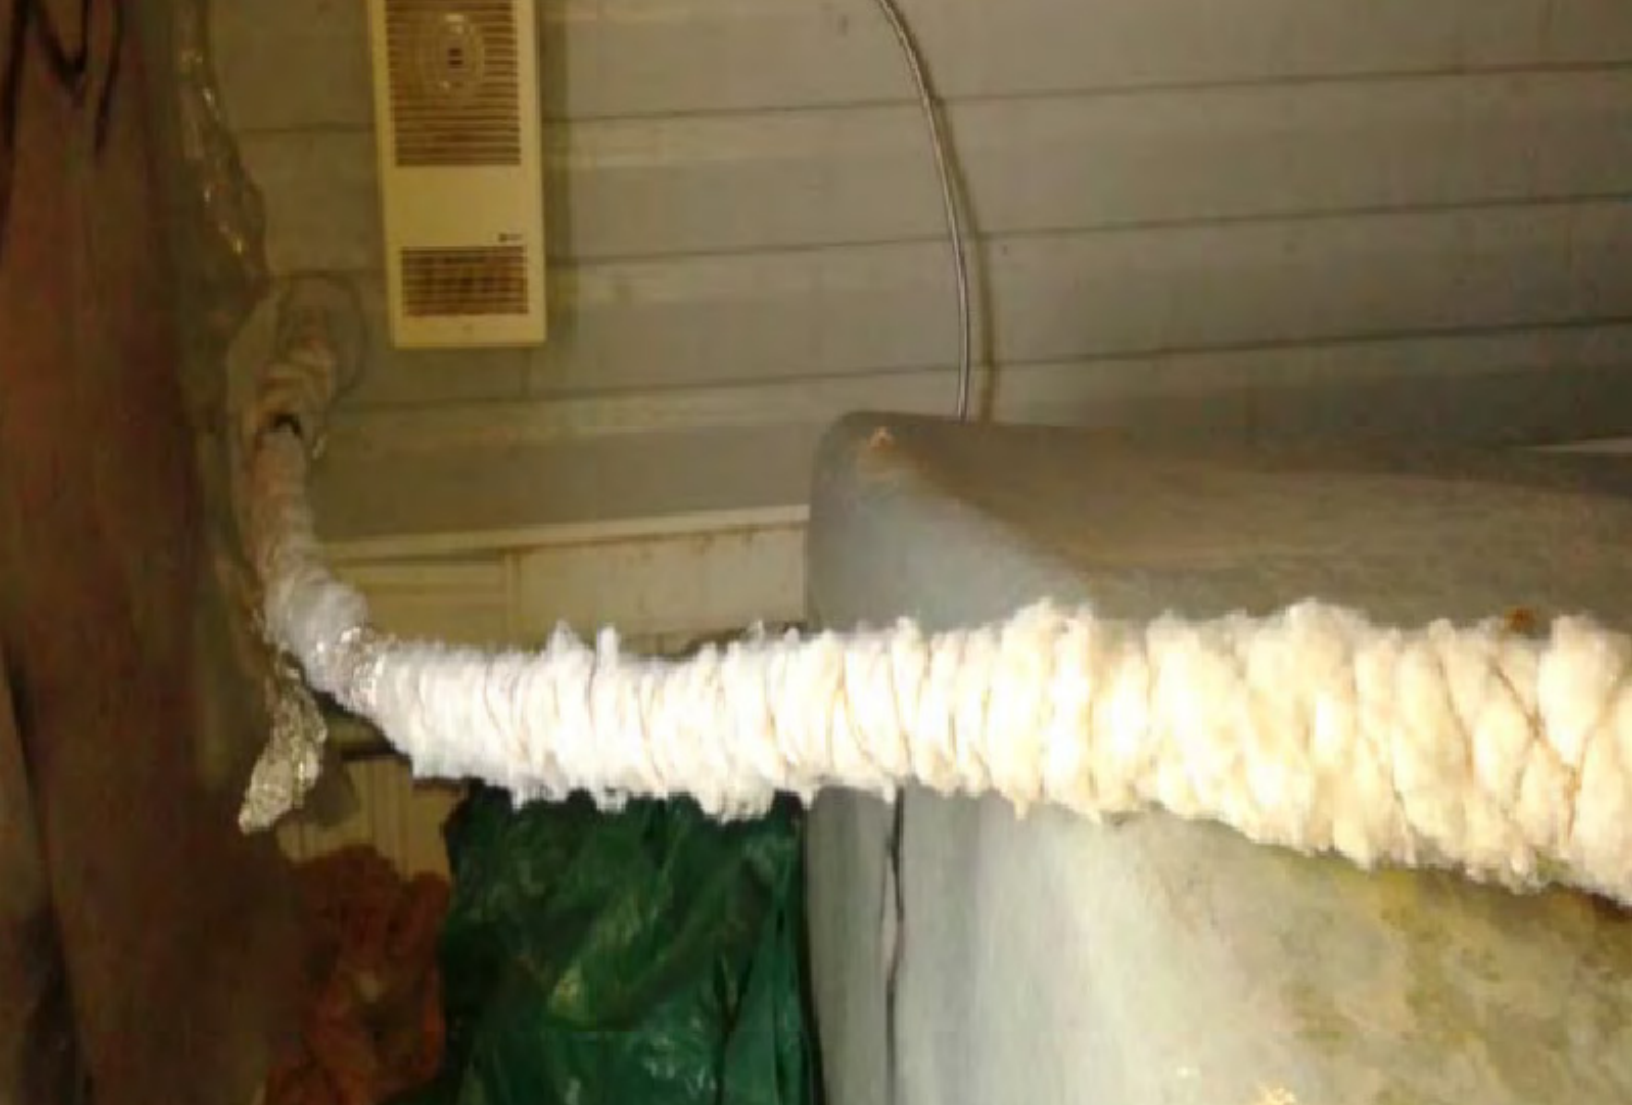
This is the water pipe leading into the house. You can see that we had to find a way to keep the pipe from freezing in the winter. We wrapped it in cotton, foil, rope – whatever we could find at the time. It helps, but when it's really cold outside it still freezes over night and we have to detach the pipe and bring it in to thaw out. After it thaws and the ice is out, we then take it out to reattach it, which isn't easy. There is a heater in the shack attached to the wall, but it doesn't help much either. The plumbers would usually come to thaw the pipes out with a torch but they couldn't come thaw them out every day (because that's how often it would happen last year) so we had to find our own way of resolving this issue

5. Reduce incidents of pipes freezing in winter. This includes well trained public works people able to fix ongoing problems and the better insulation of tanks.

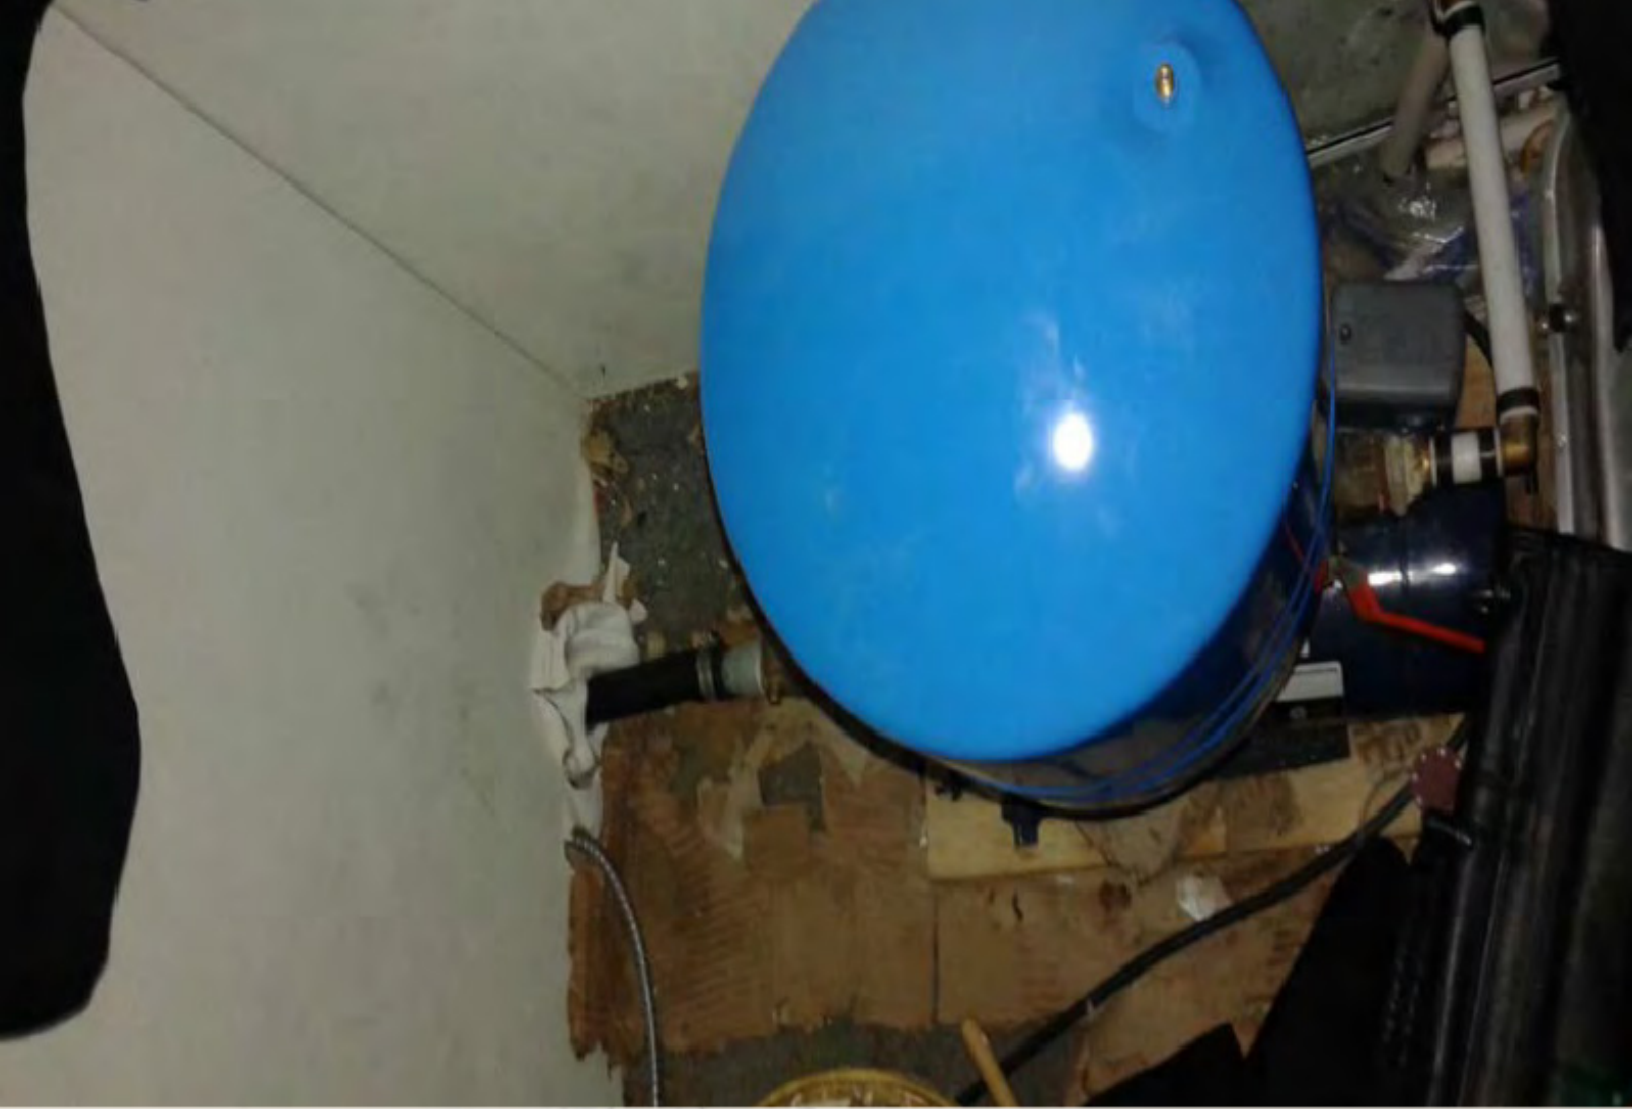
Here is the pump that sucks the water from the tank. You can see that there has been some damage to the wall from trying to pull the pipe out, trying to put it back in, sometimes the pump would have to be repaired and once had to be replaced because when the pipes would freeze over-night the pump would still be running but with nothing going through. When that happens everyone is usually asleep. This pump is in a closet of one of the rooms and sometimes it would leak from taking it out and putting it back so there is a little damage to the floor.

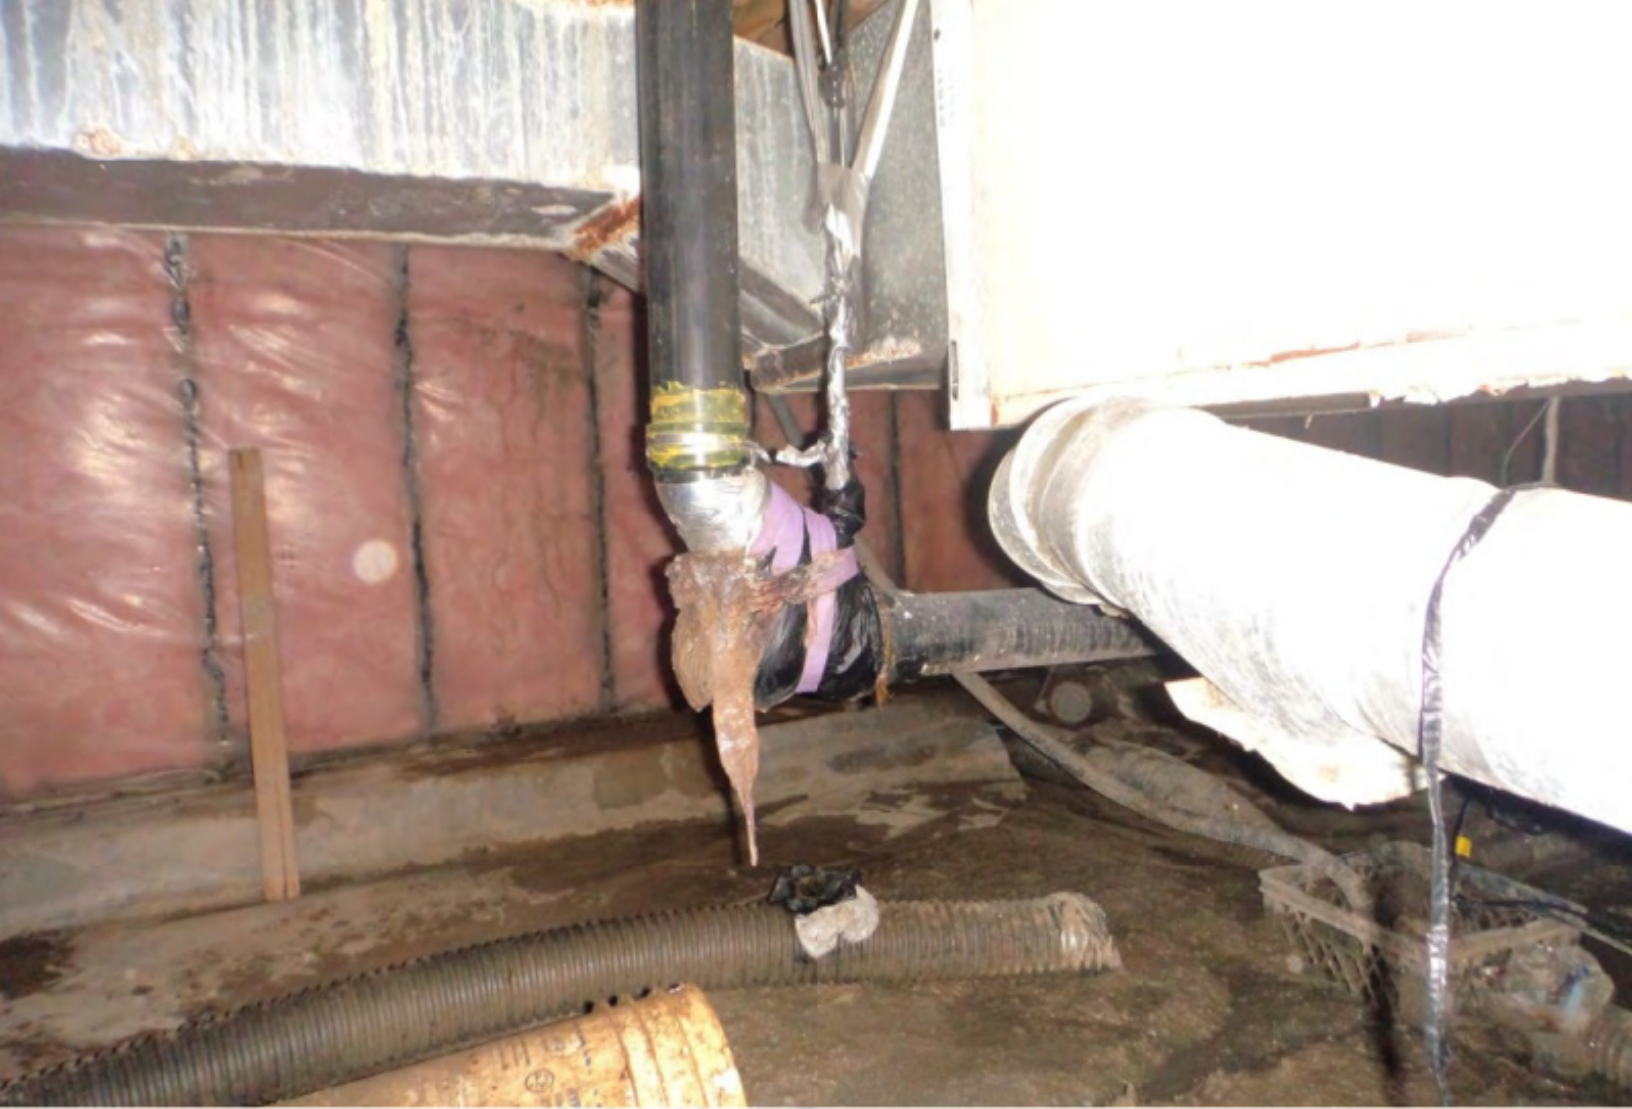
In the picture you can see a drainage pipe that has been broken, temporarily repaired with tape and plastic, but still leaking.

Notice that there is neither OSB on the side walls of the crawl space nor plastic on the ground with sand on top. Without these, there is a high risk of mold forming which can lead to serious health concerns.

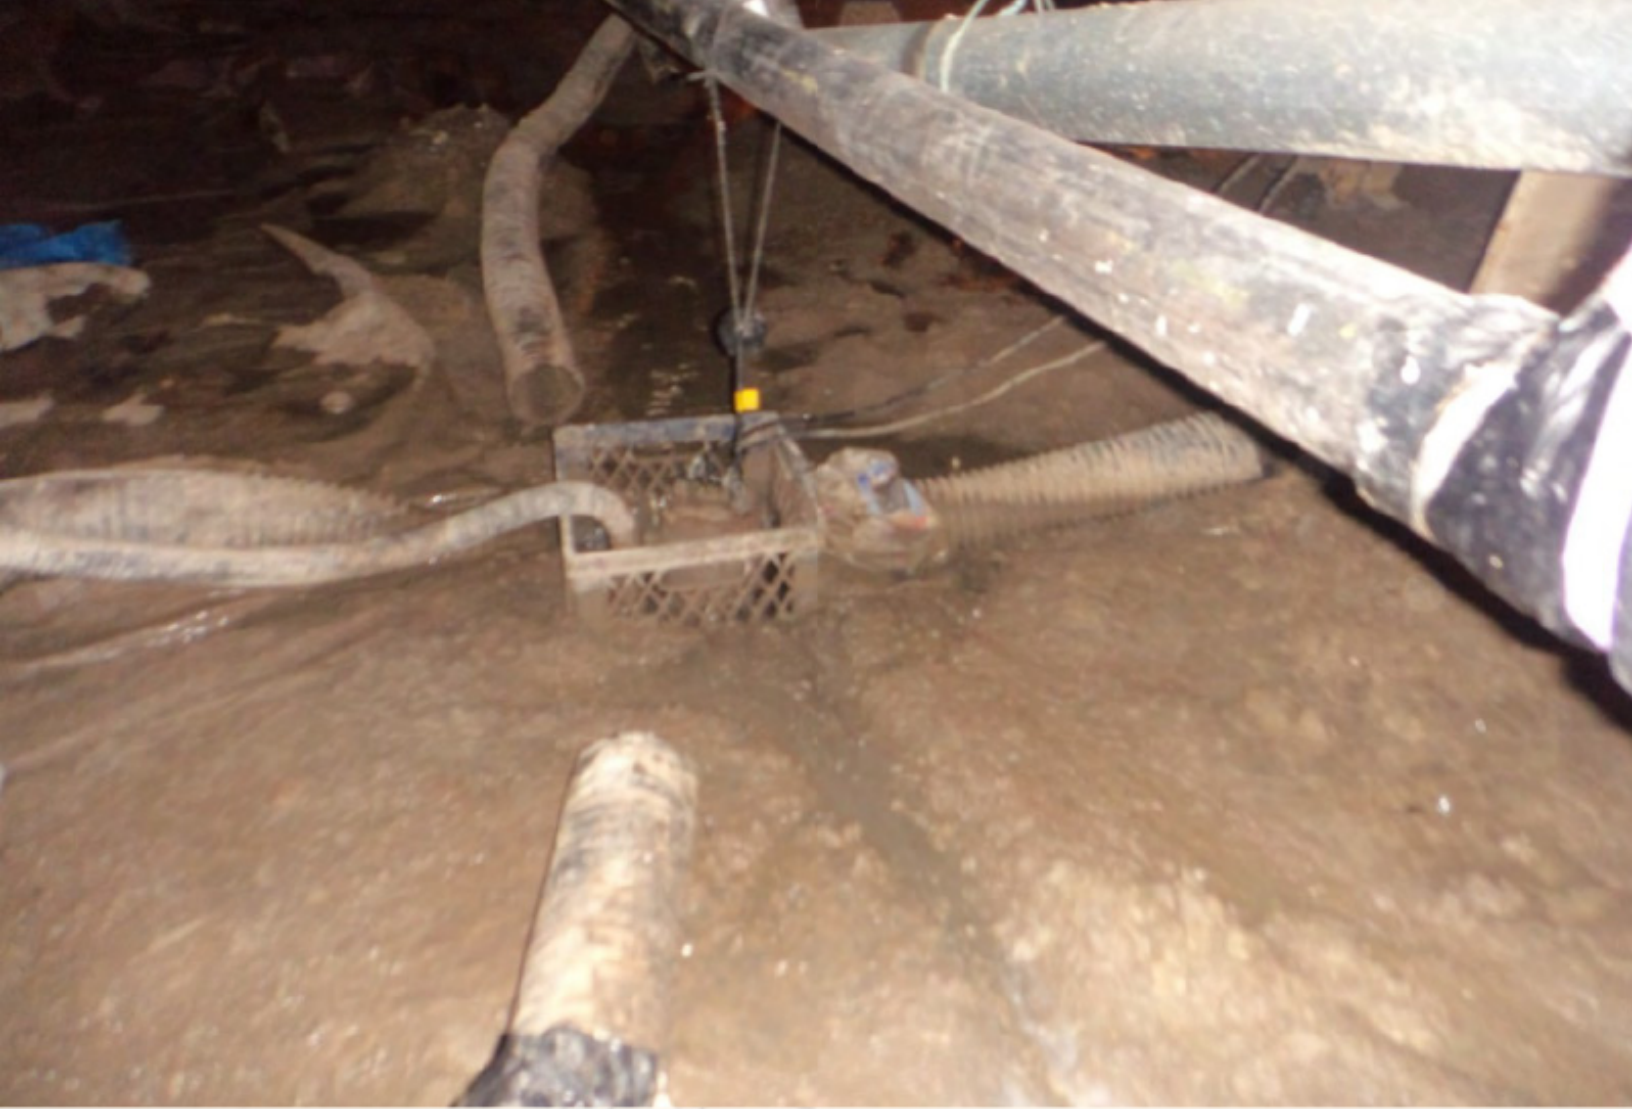
Due to issues of freezing and bursting pipes, water often accumulates in the crawl spaces of homes. You can see the moisture buildup everywhere in this picture.

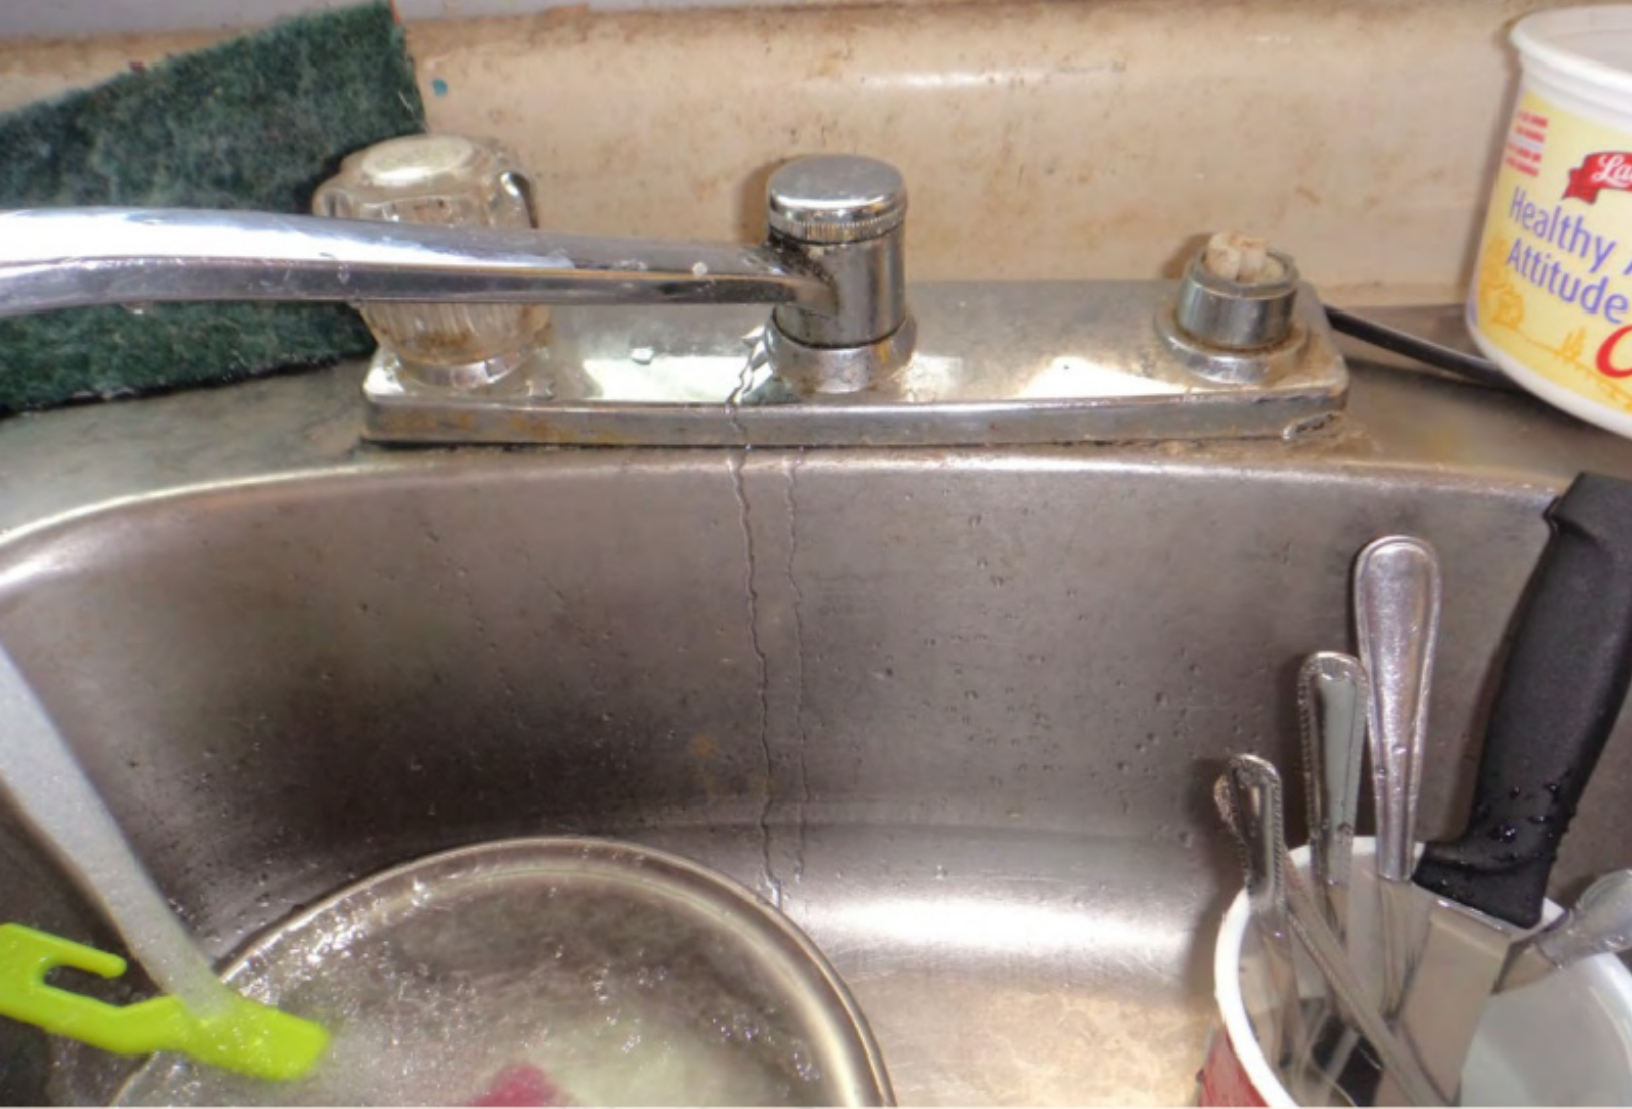
Leaking taps increase the demand for water. If many of the houses in the community have such issues, this condition increases the demand on an already overtaxed water treatment plant and the sewage lagoon.
