The Right to Clean Water in First Nations

The Photovoice Project 2nd Edition

The Photovoice Project

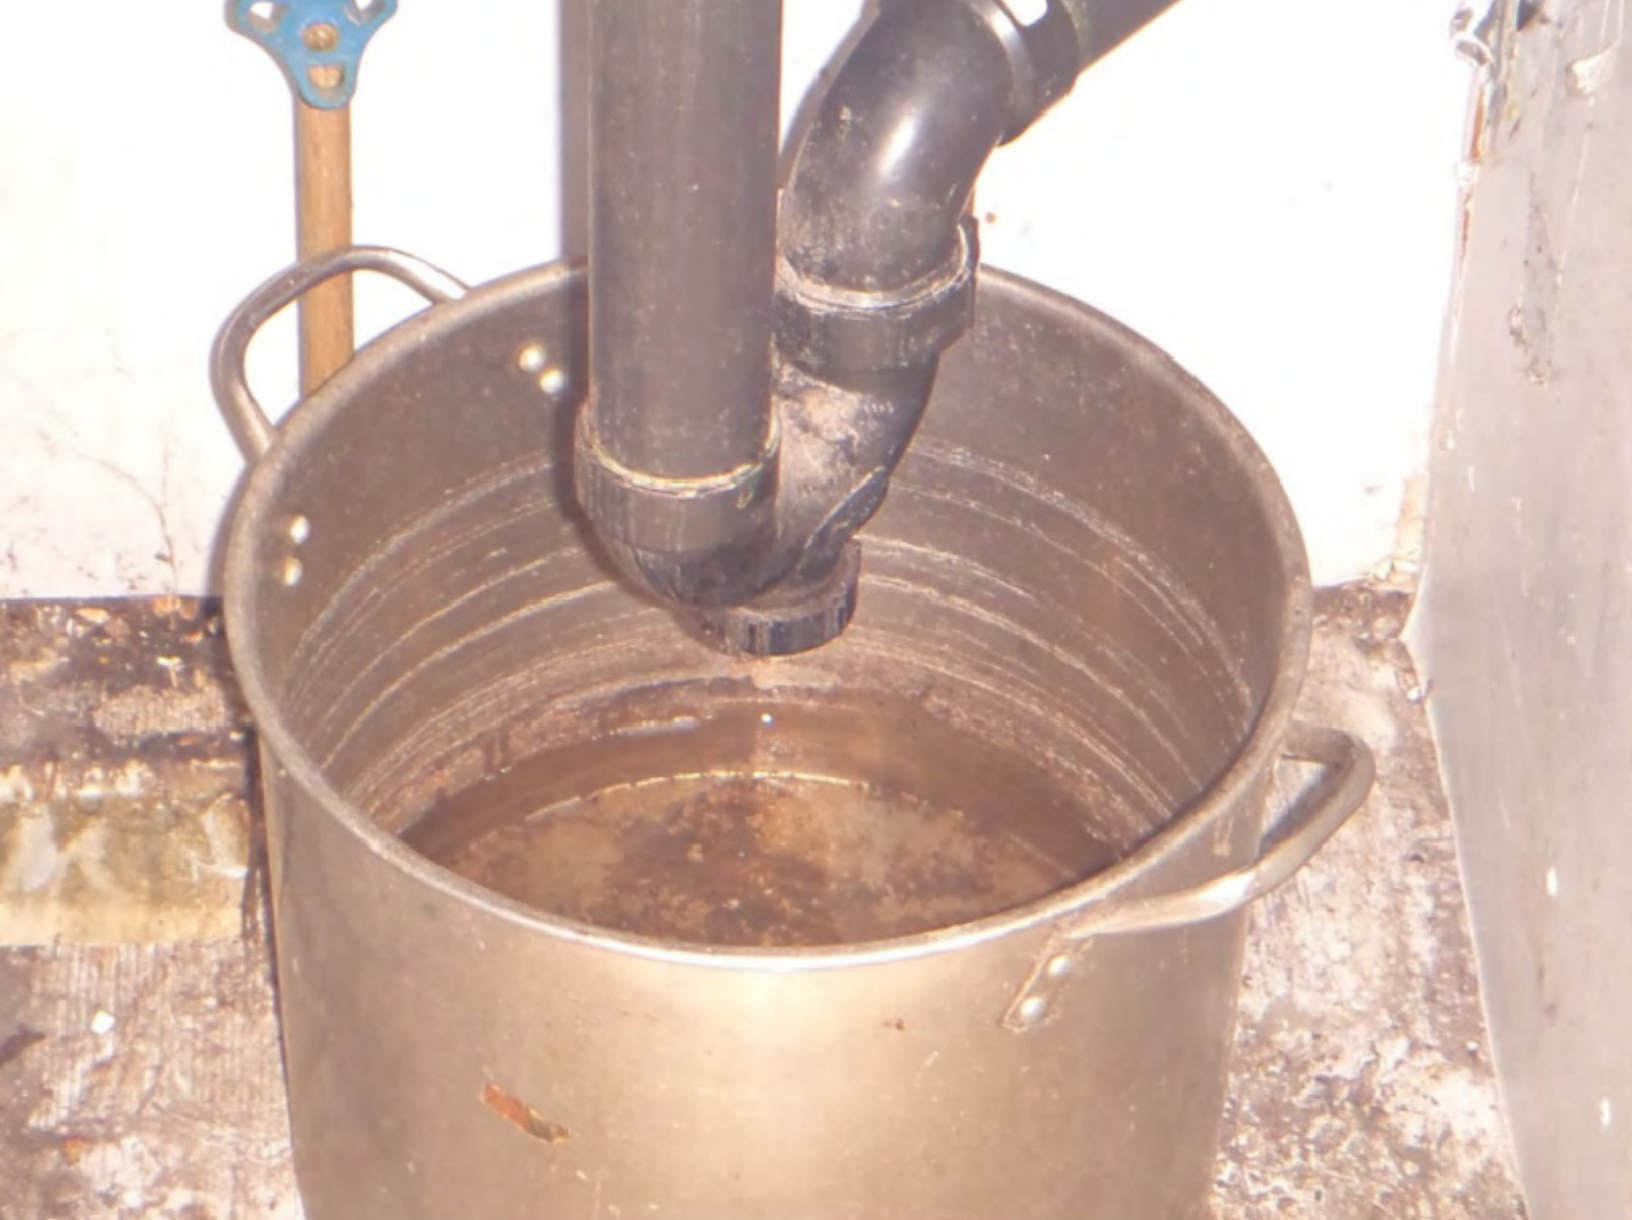
**Leaky pipes have the same effect as leaky taps.
In addition, it increases the amount of moisture
and risk of mold in our homes.**

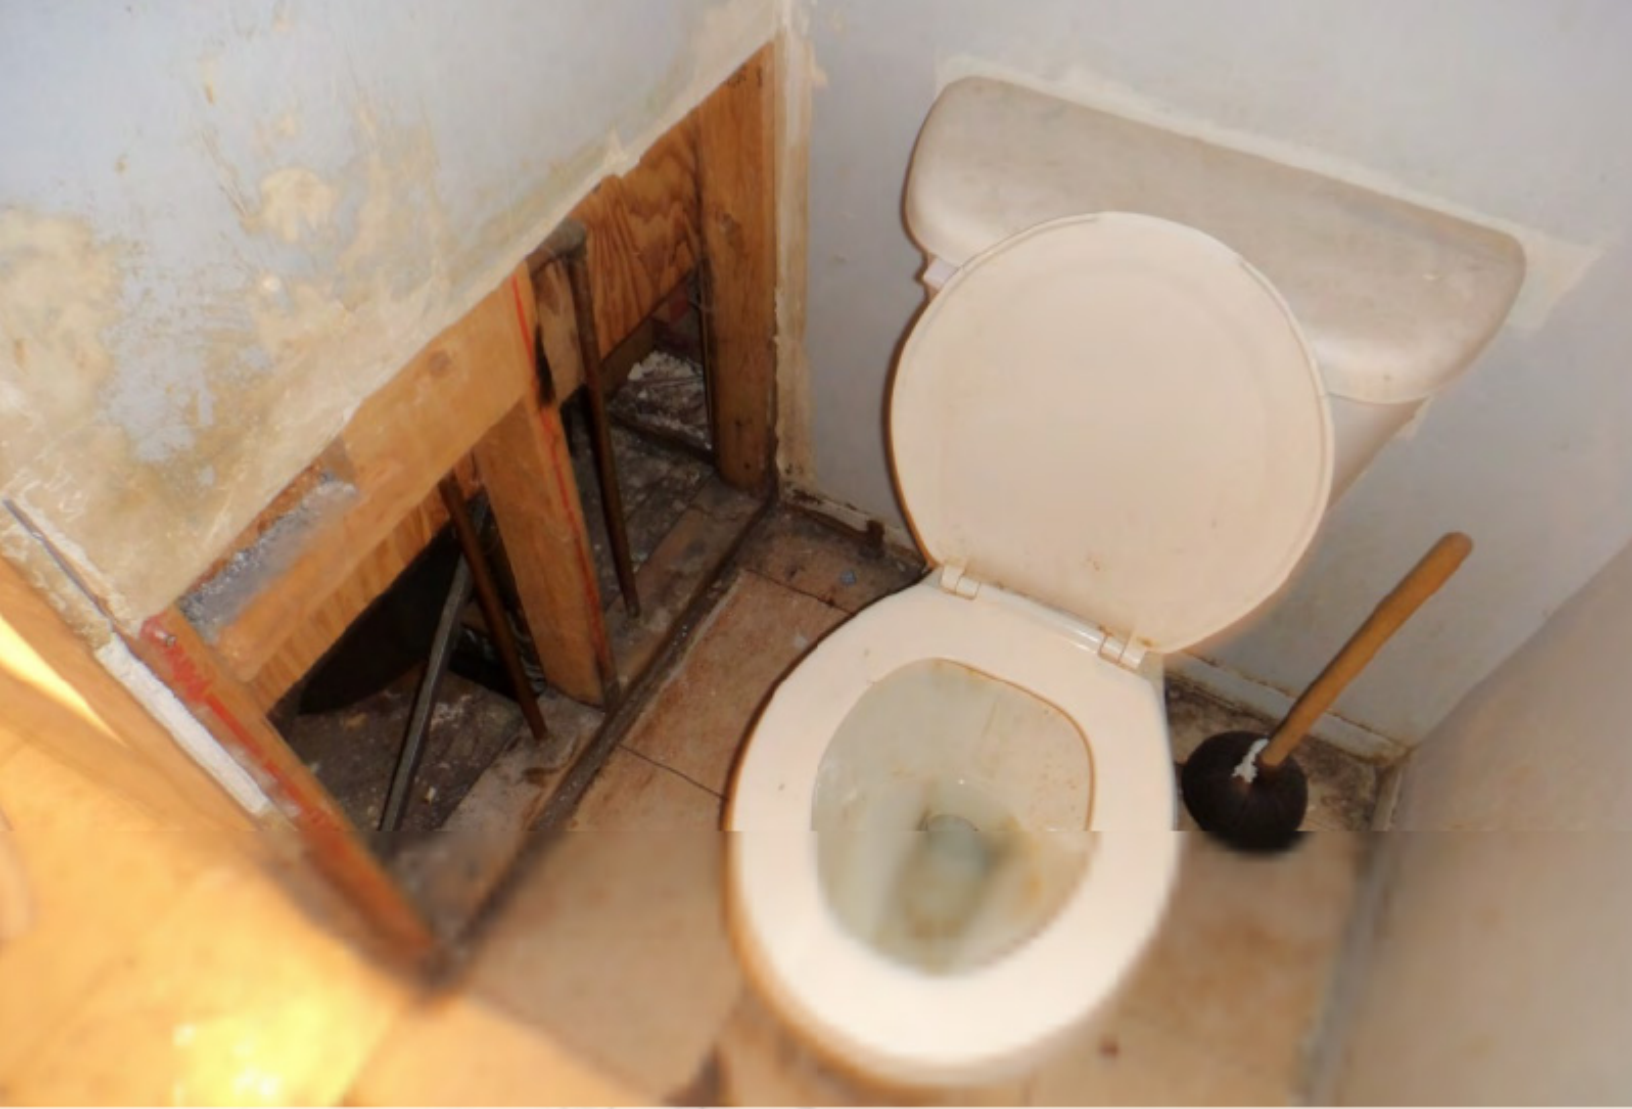
This picture shows the damage that can result from leaky or frozen pipes. If not repaired, it increases the risk of sickness from mold build up.

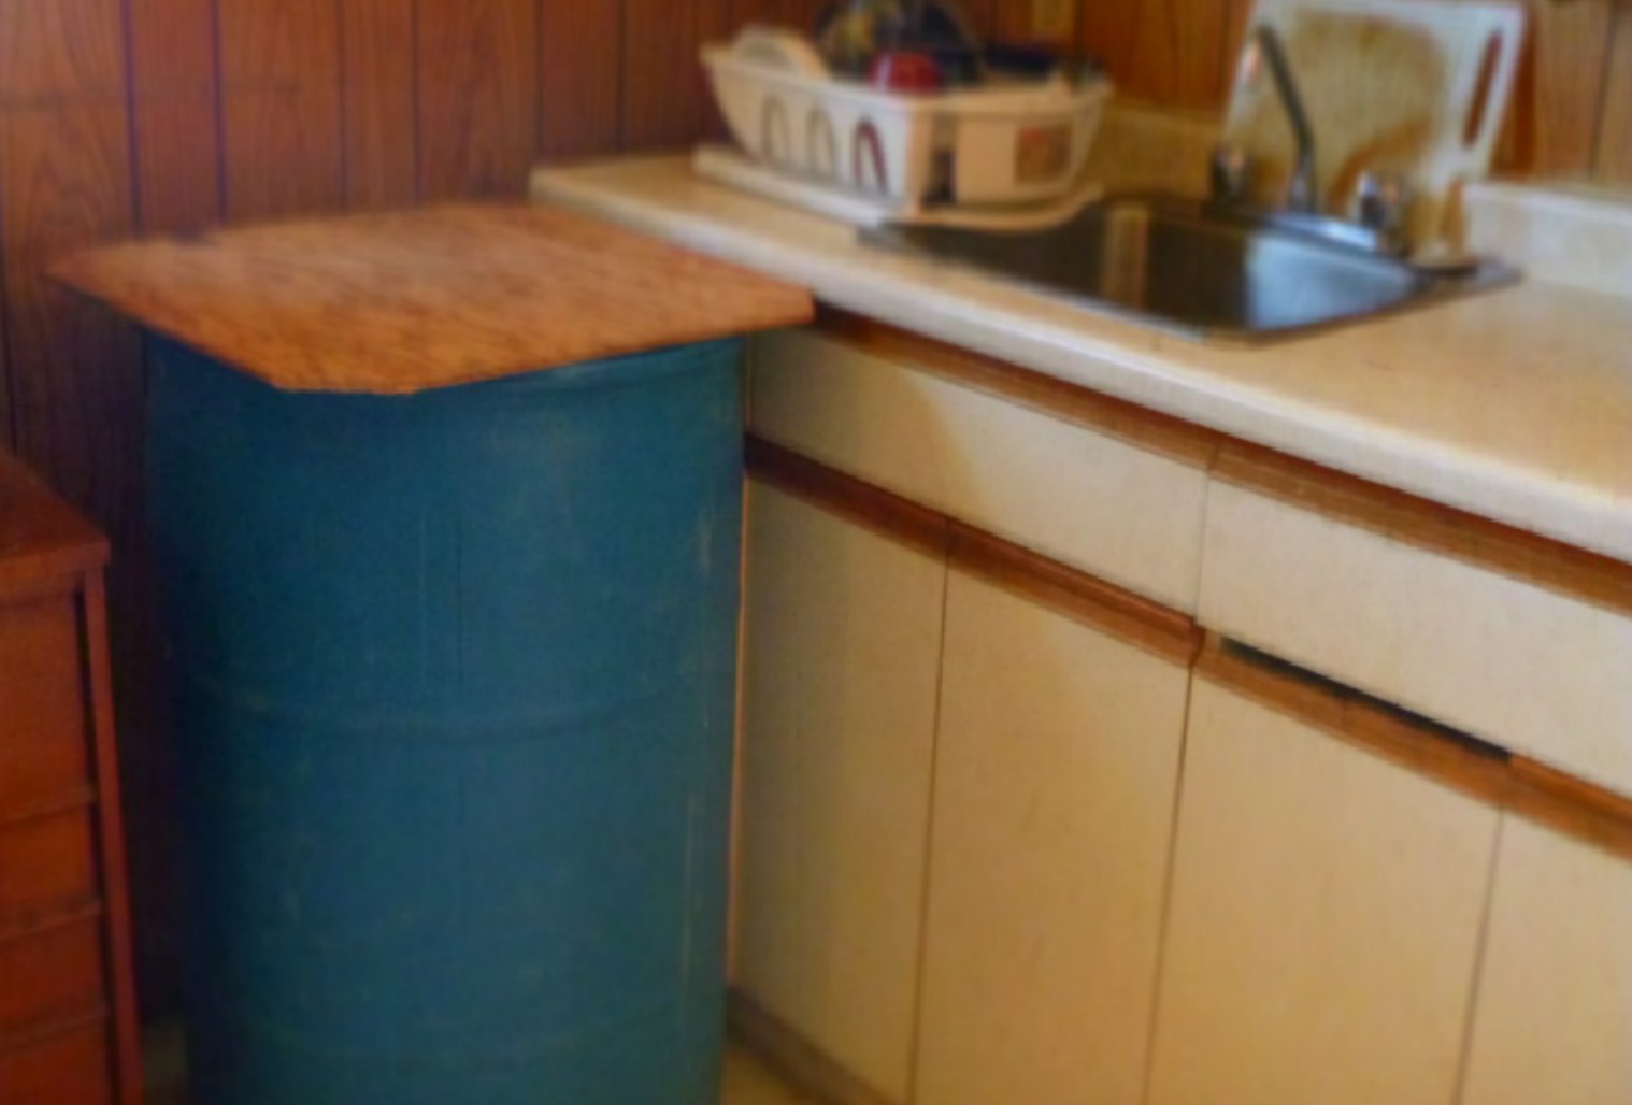
With the many water breaks and issues of freezing pipes, some community members have resorted to storing water in large containers like this one in their homes. We used this water barrel all through the last winter season because our pipes froze. We are on the main line of the water system.

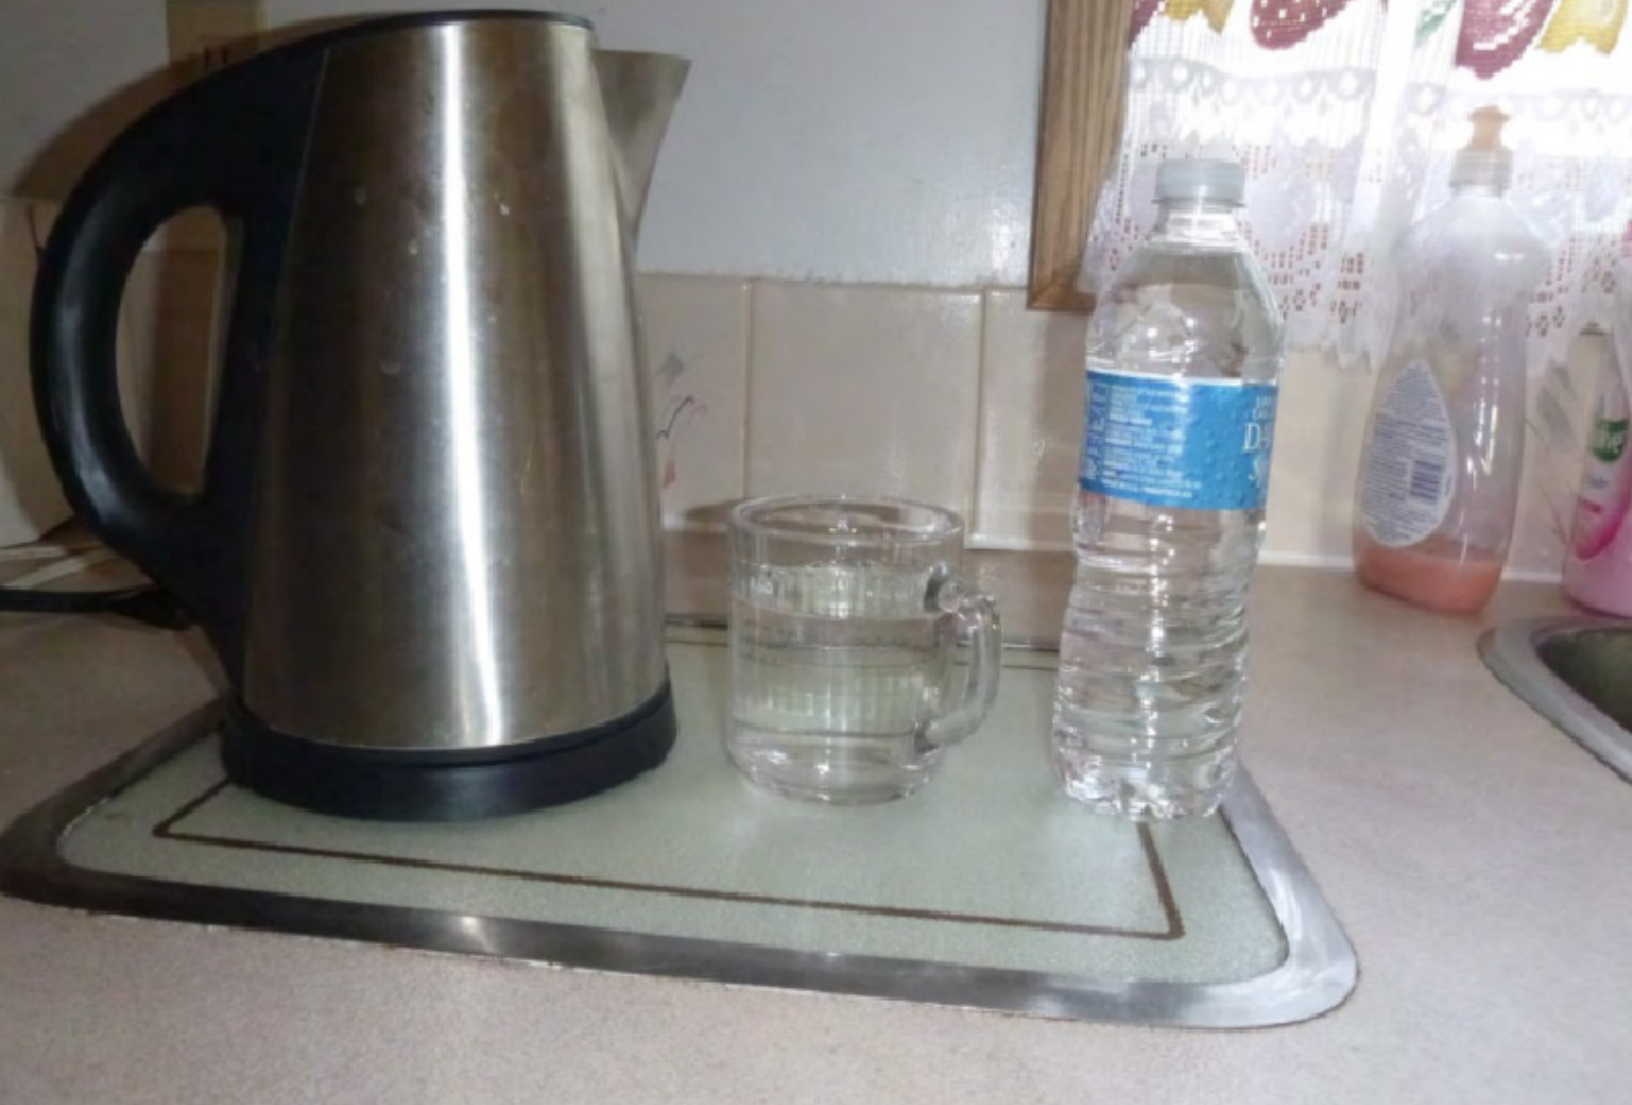
Bottled Water is not always the best to drink because when you leave bottled water in your vehicle, the heat cause a chemical to be released from the plastic bottle into the water which can be hazardous to your health. It is also very expensive to purchase and transport to the community. Anyway, how can we be sure the water in the bottle you purchased is any cleaner or safer than your tap water? Boiling your water is the best way to ensure it is suitable to drink. Filtering devices and chemical purification products are not as effective. Boiling your water kills all kinds of microorganisms such as bacteria, parasites and viruses.

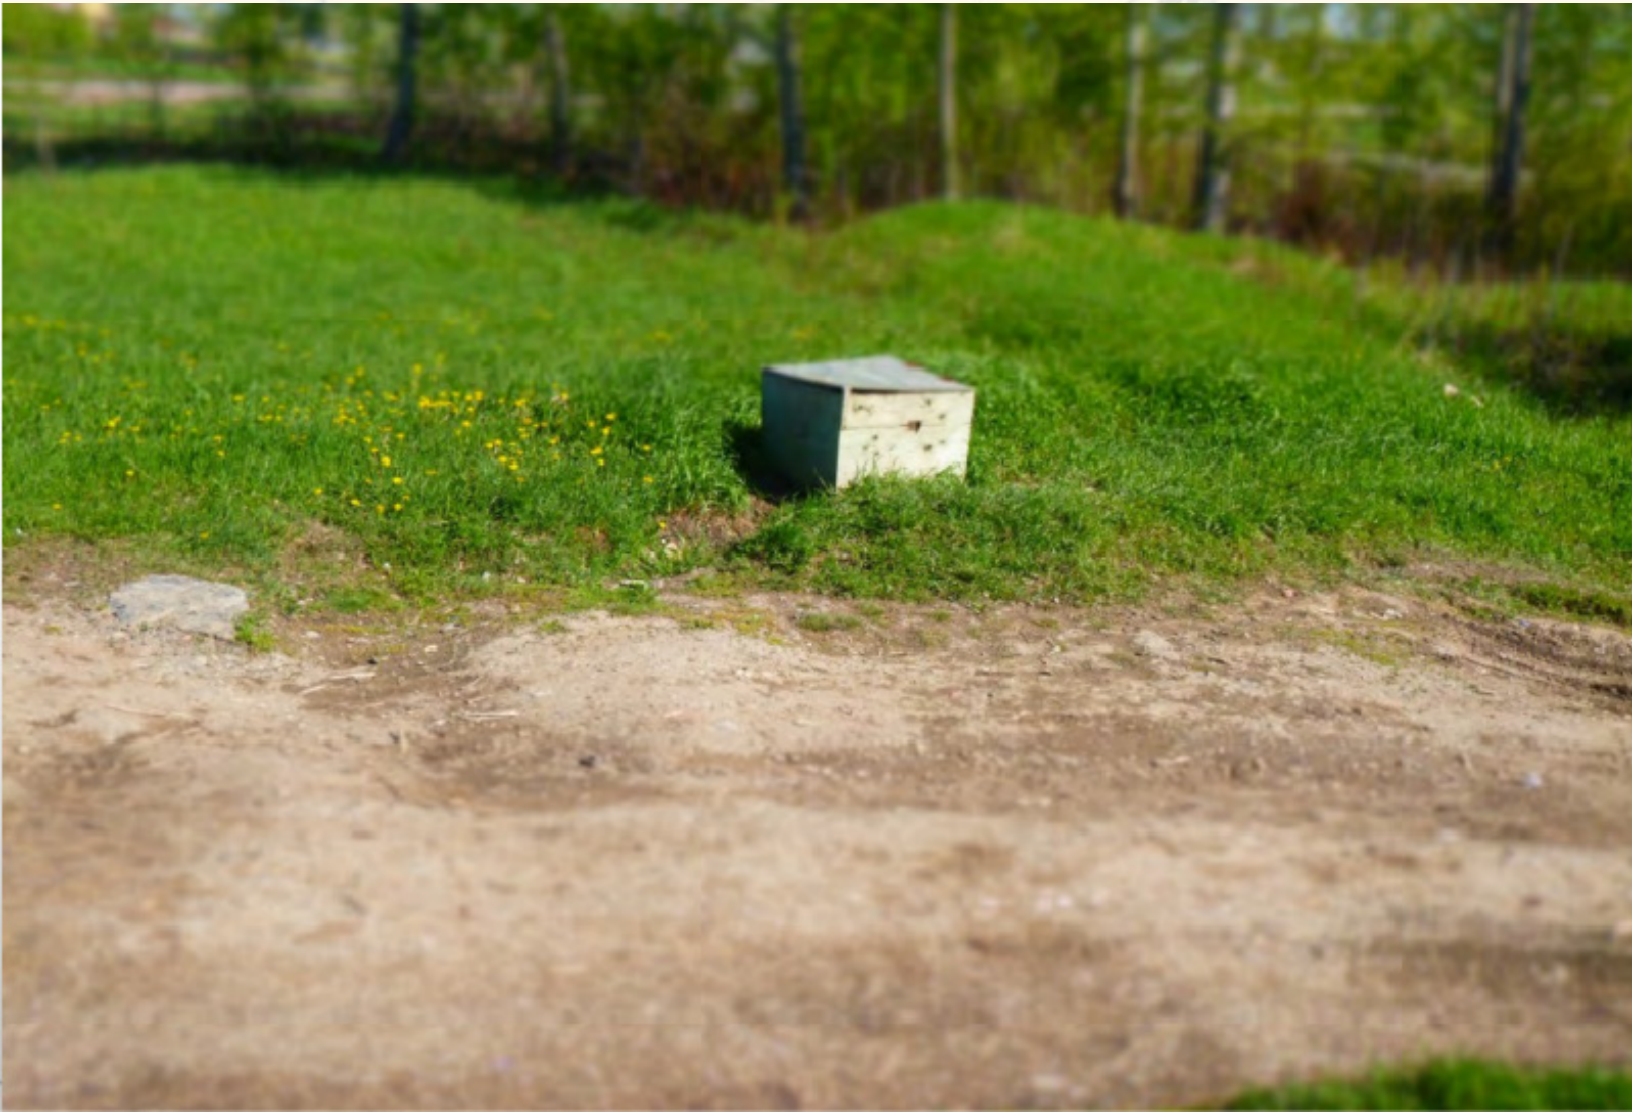
This picture is showing the sewage tank right outside the doorway of this house. Vehicles drive right by on the road with the pipes sticking out of the ground coming from the house.

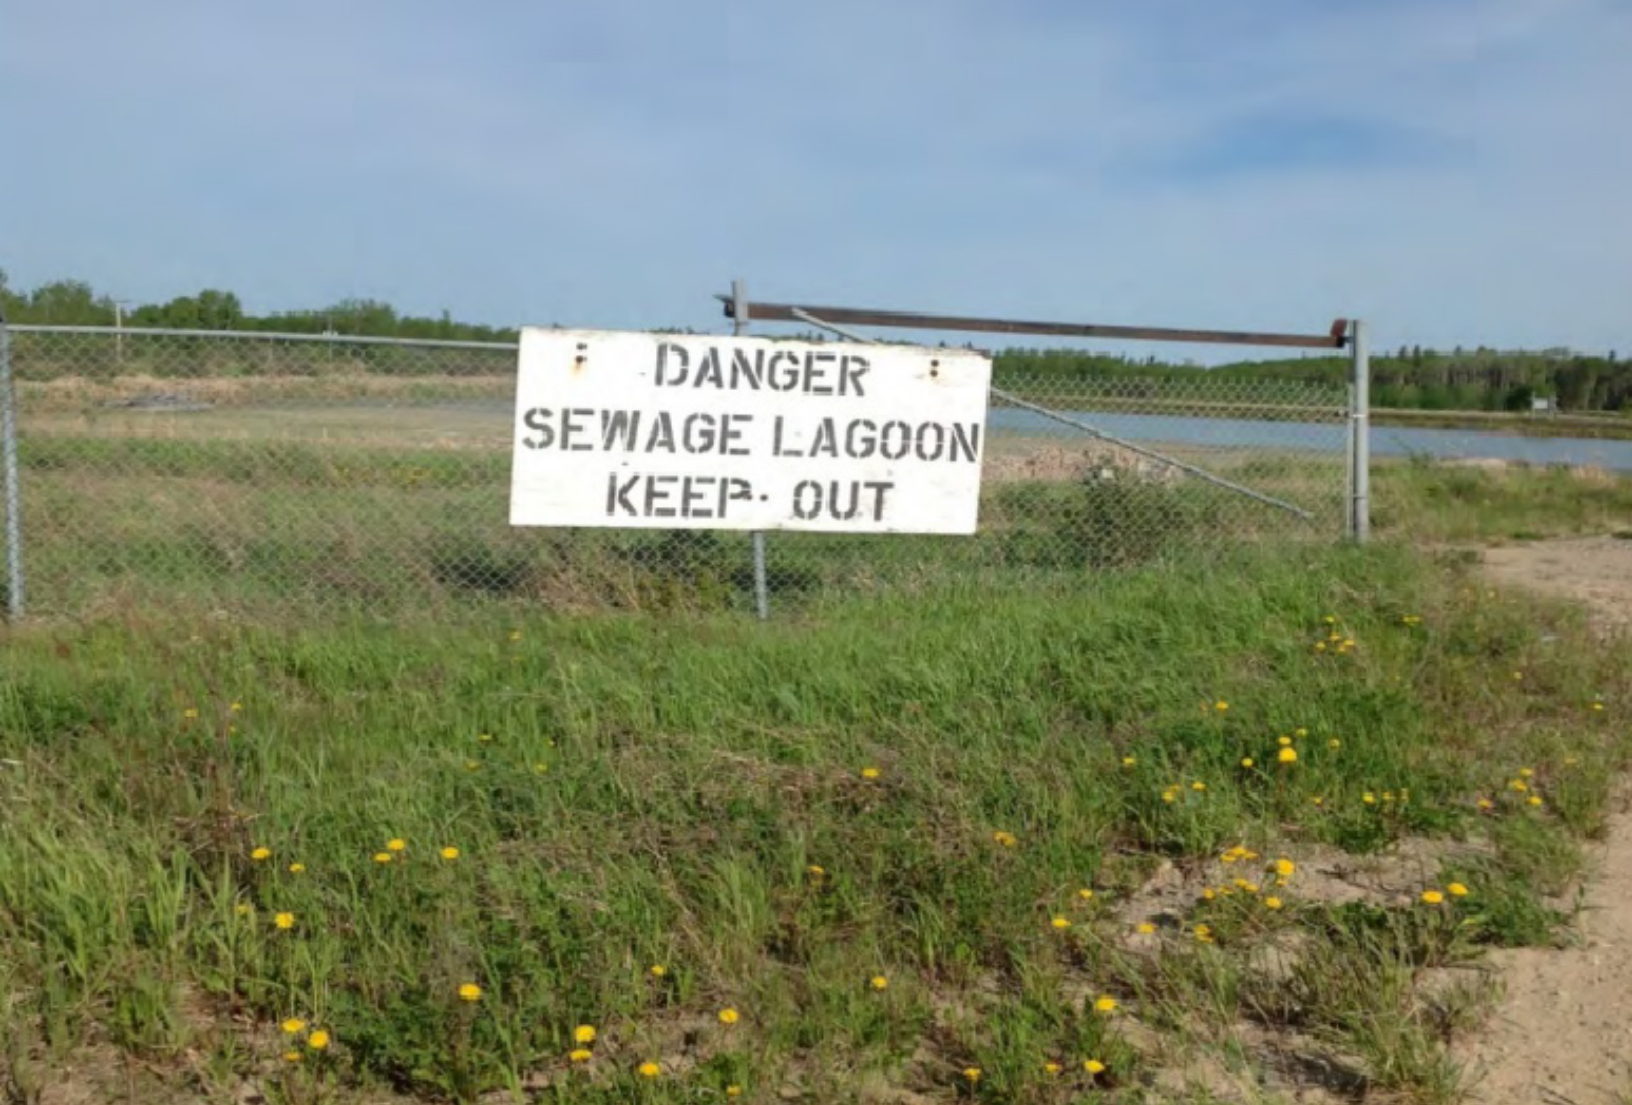
This is the lagoon at Mitchell's Point. It is where waste and sewage from every home and organization in the community is disposed. There are three cells to the system.

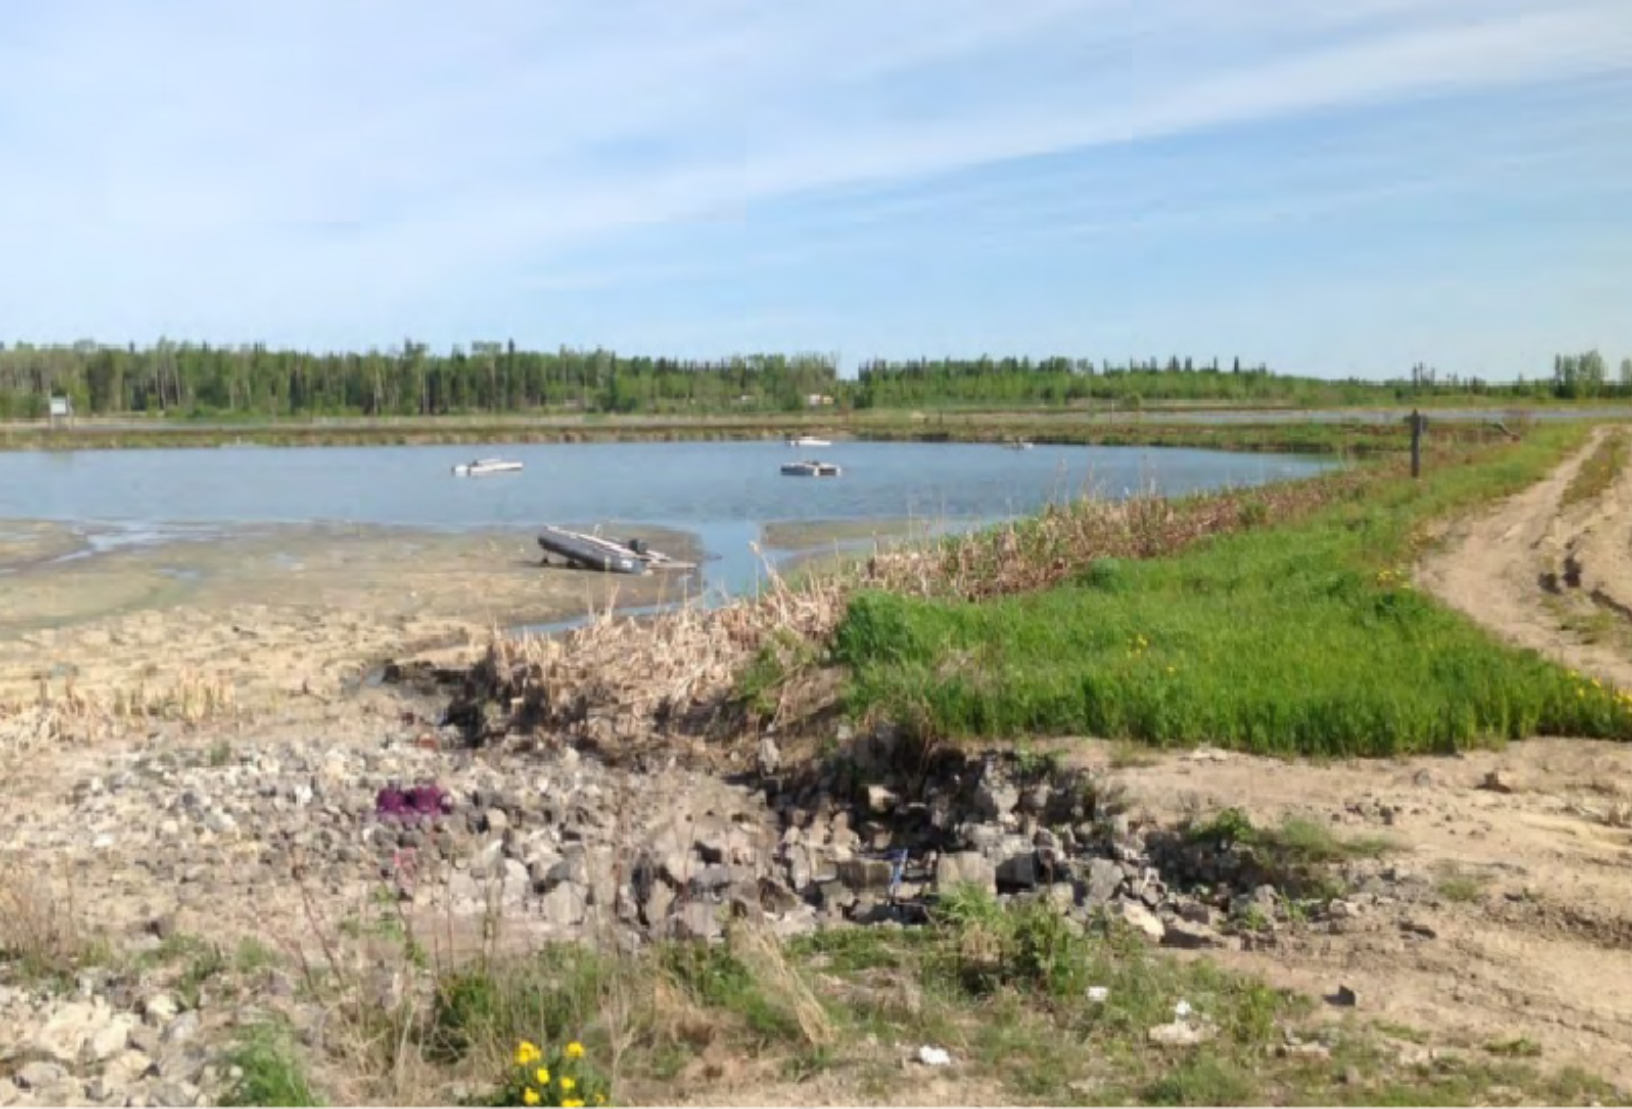
This picture is of the lagoon's closet cell (Cell 3) and is made up of all sewage. The white raft-looking things are floating pumps. The lagoon has a filtering system that flows to Cell 2 than flows through to Cell 1. This system of cells makes the "water" almost clean enough to consume. Before freeze up and the winter months, Cell 1 is to be drained. In the past there was a mistake once where the sewage and waste water in Cell 3 was drained instead of Cell 1 and made its way into our lake where we draw our drinking water from.

6. Community education on what should (and should not) go in the toilet and sink. The purpose is to reduce contaminants and non-degradable material ending up in the sewage lagoon.

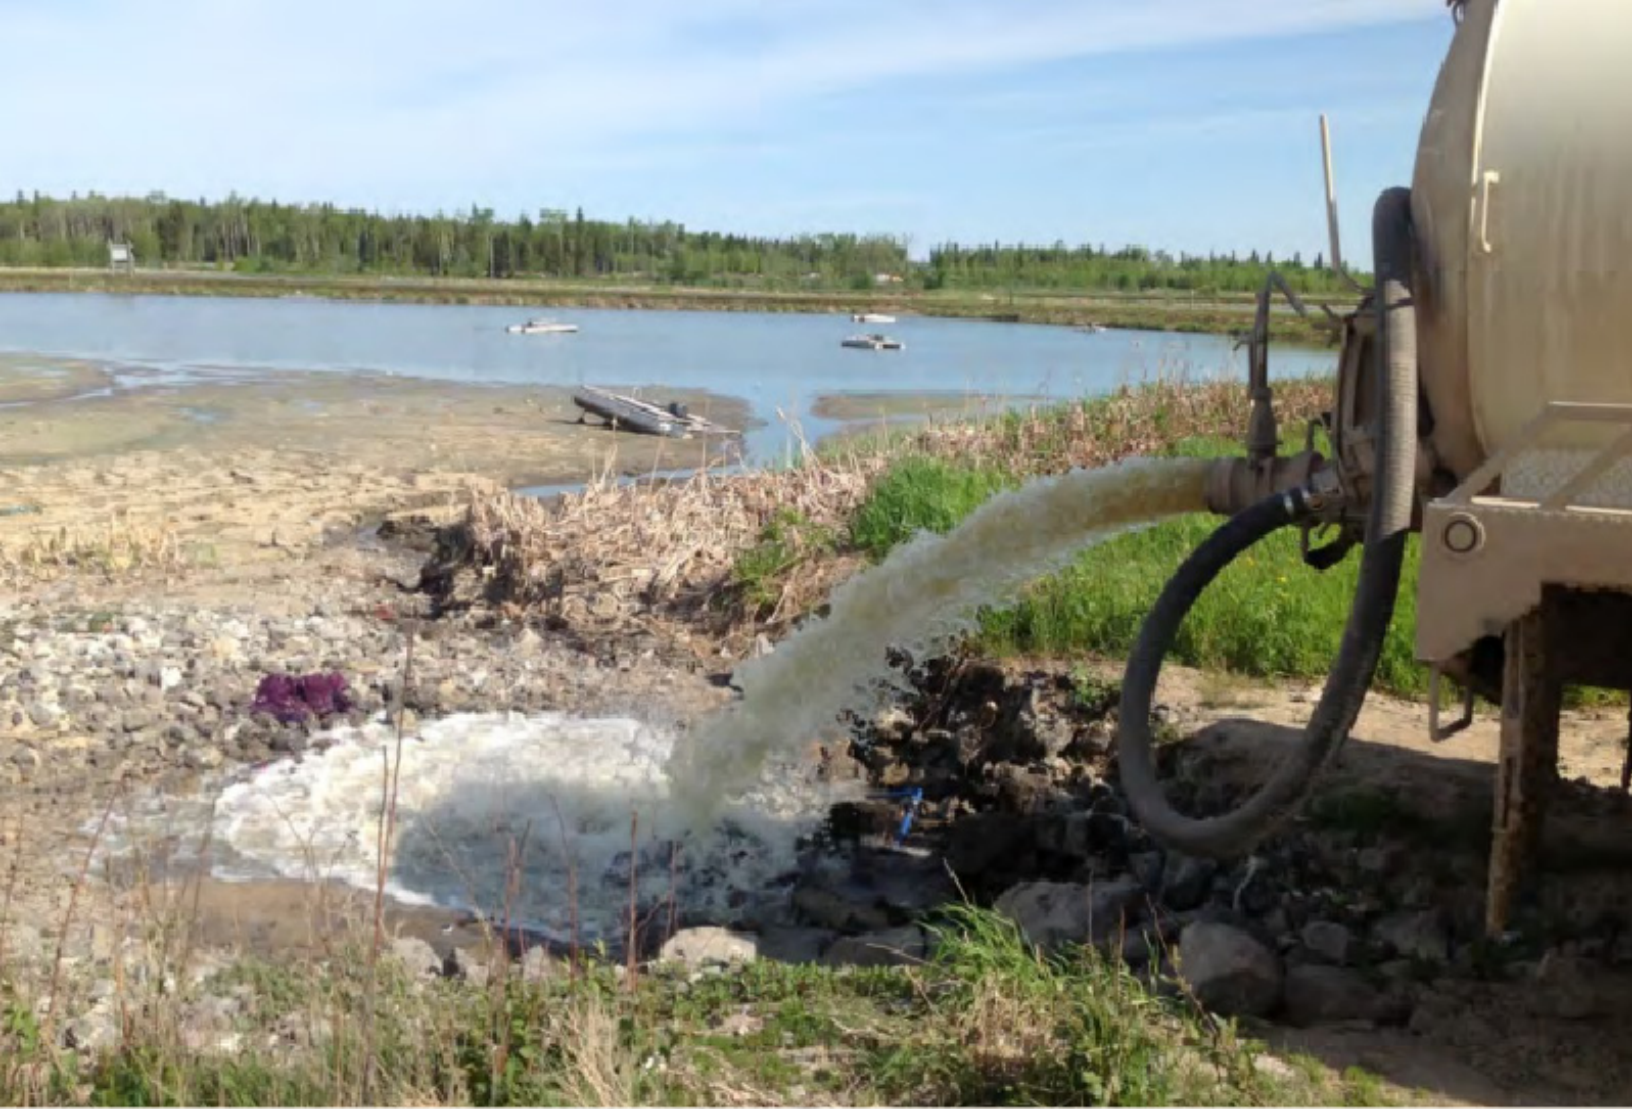
The sewage trucks dump raw sewage into Cell 3 of the lagoon. What was once a swamp now looks nothing like a swamp. The community really needs a sewage treatment plant for the people of Nisichawayasihk Cree Nation.
